Great Rivers Greenway

GIS Bridge Inventory Report

By Christopher Cattron

July 28, 2017

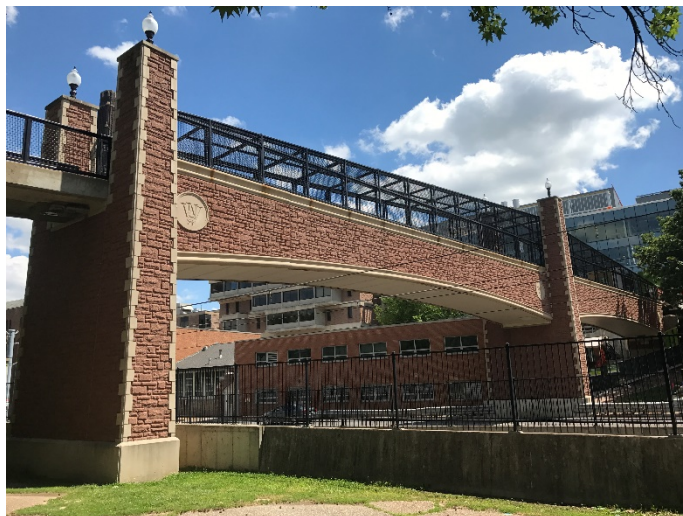
Bridge 1 - Forest Park Pkwy Pedestrian Bridge to Washington University Campus

General Info and Condition	
Install Date	2004
Greenway	Centennial
Maintained By	Washington Univ.
General Condition	Good
Vegetation Condition	None

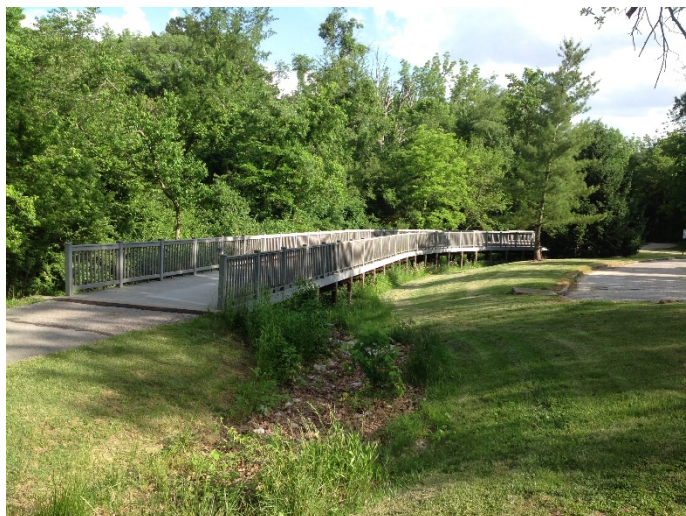
Bridge 2 - St. Vincent County Boardwalk

General Info and Condition	
Install Date	2006
Greenway	St. Vincent
Maintained By	St. Louis County Parks
General Condition	Good
Vegetation Condition	Moderate

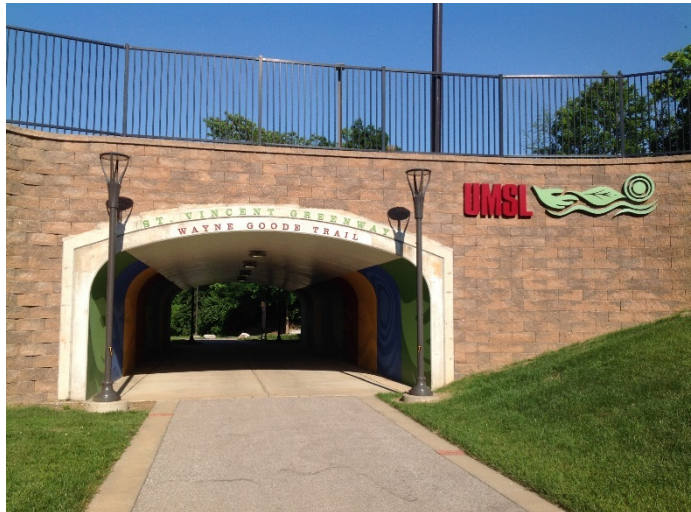
Bridge 4 - UMSL Campus Pedestrian Tunnel

General Info and Condition	
Install Date	2012
Greenway	St. Vincent
Maintained By	UMSL
General Condition	Good
Vegetation Condition	None

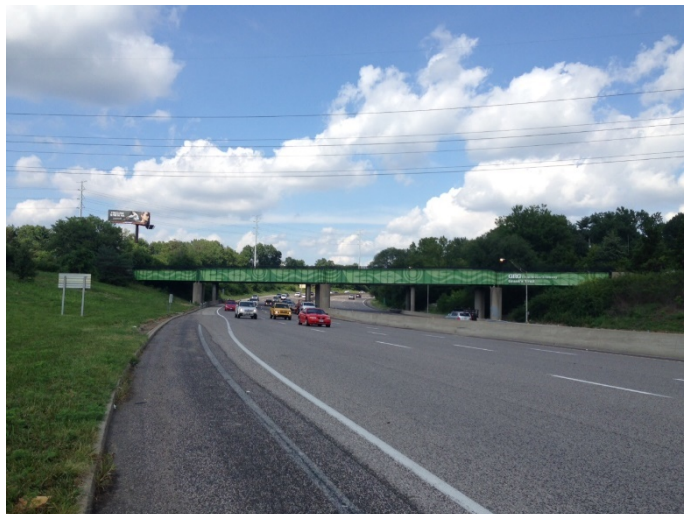
Bridge 5 - Grant's Trail Bridge over I-44

General Info and Condition	
Install Date	1968
Greenway	Gravois
Maintained By	St. Louis County Parks
General Condition	Good
Vegetation Condition	Moderate

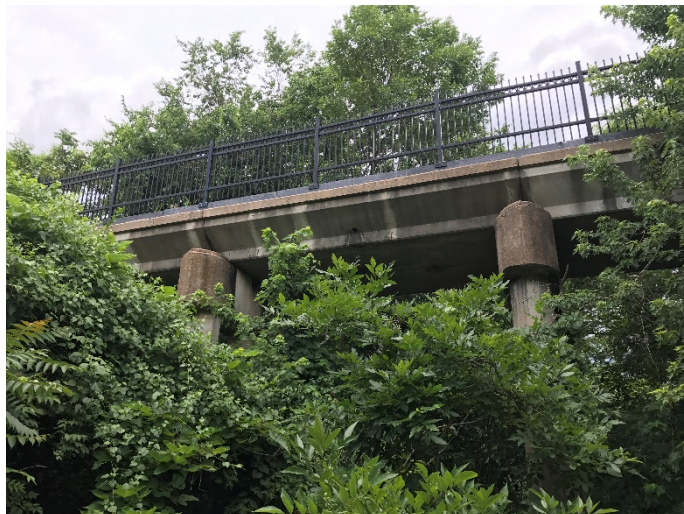
Bridge 6 - Gravois Creek 1952 RR Bridge

General Info and Condition	
Install Date	1952
Greenway	Gravois
Maintained By	Great Rivers Greenway
General Condition	Fair
Vegetation Condition	Heavy

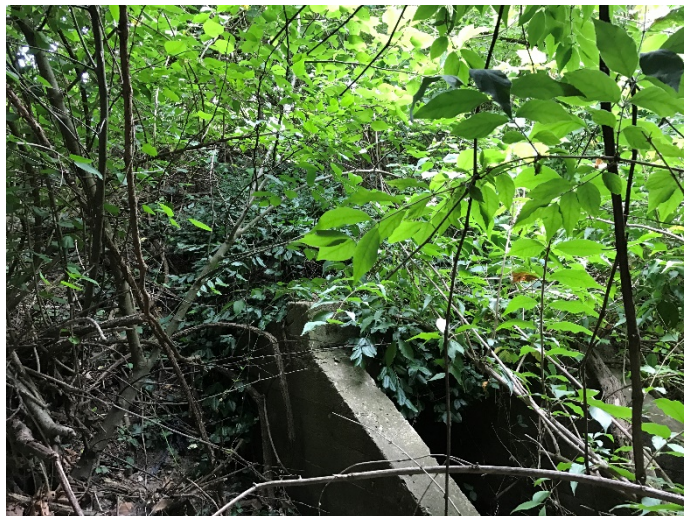
Bridge 7 - Grant's Farm Unknown Culvert

General Info and Condition	
Install Date	
Greenway	Gravois
Maintained By	St. Louis County Parks
General Condition	Poor
Vegetation Condition	Heavy

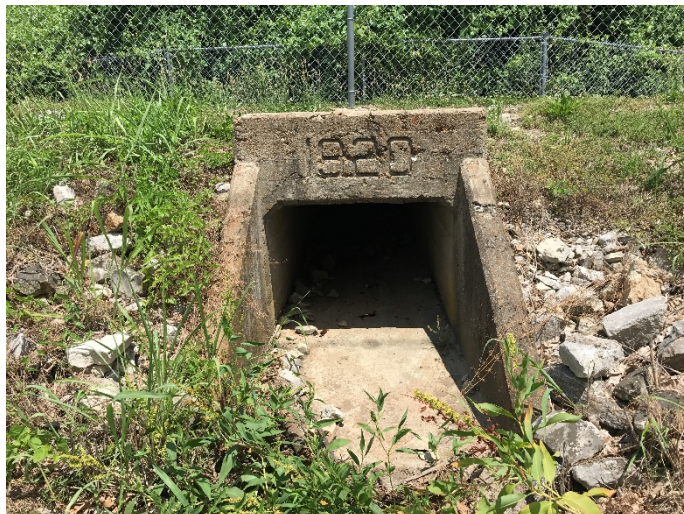
Bridge 8 - Grant's Trail 1920 Box Culvert

General Info and Condition	
Install Date	1920
Greenway	Gravois
Maintained By	St. Louis County Parks
General Condition	Fair
Vegetation Condition	Light

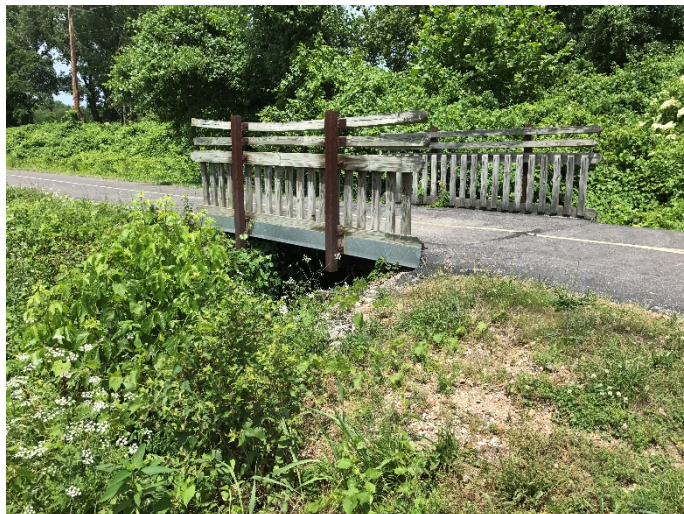
Bridge 9 - Grant's Trail Old Short- span RR Bridge

General Info and Condition	
Install Date	Unknown
Greenway	Gravois
Maintained By	St. Louis County Parks
General Condition	Poor
Vegetation Condition	Heavy

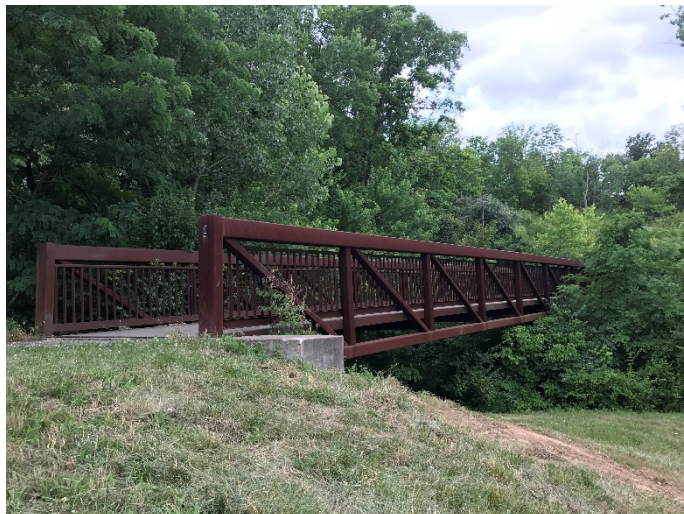
Bridge 10 - Clydesdale Park Bridge South

General Info and Condition	
Install Date	2005
Greenway	Gravois
Maintained By	St. Louis County Parks
General Condition	Good
Vegetation Condition	Heavy

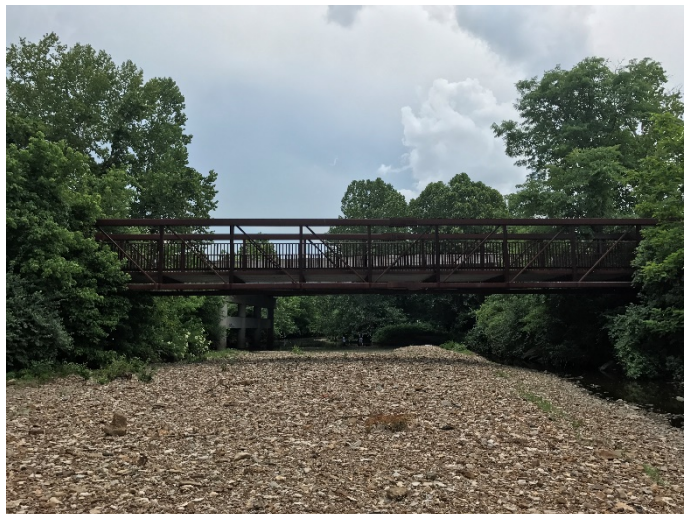
Bridge 11 - Clydesdale Park Bridge North

General Info and Condition	
Install Date	2005
Greenway	Gravois
Maintained By	St. Louis County Parks
General Condition	Good
Vegetation Condition	Heavy

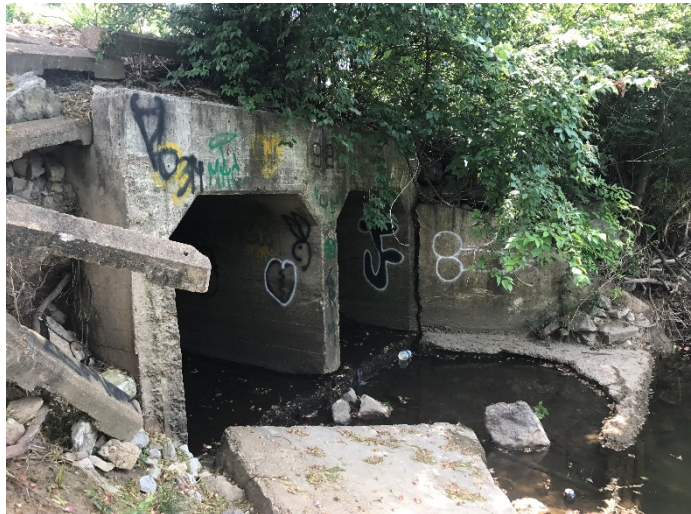
Bridge 14 - Grant's Trail 1923 Double Box Culvert

General Info and Condition	
Install Date	1923
Greenway	Gravois
Maintained By	St. Louis County Parks
General Condition	Poor
Vegetation Condition	Moderate

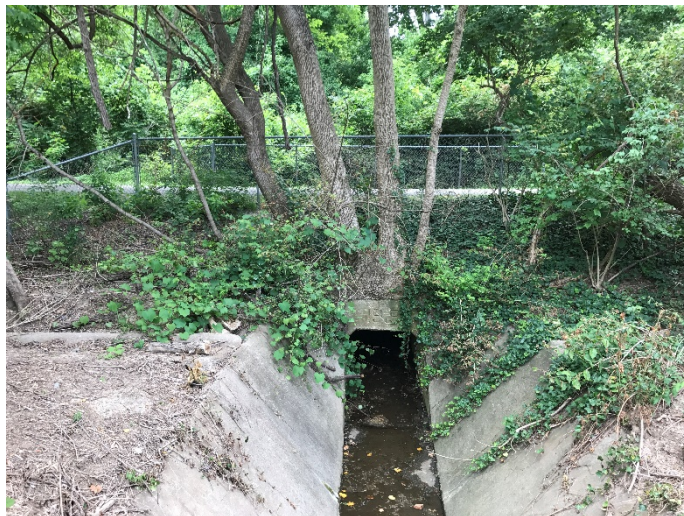
Bridge 15 - Grant's Trail 1919 Box Culvert

General Info and Condition	
Install Date	1919
Greenway	Gravois
Maintained By	St. Louis County Parks
General Condition	Poor
Vegetation Condition	Heavy

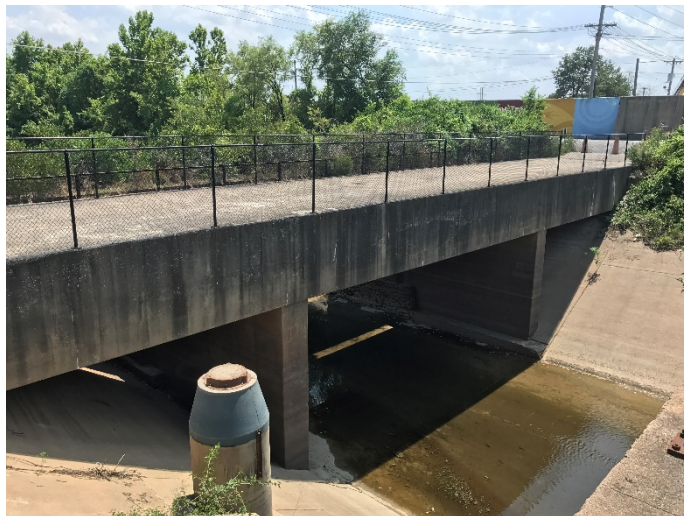
Bridge 17 - Riverfront Trail Maline Creek Crossing

General Info and Condition	
Install Date	Unknown
Greenway	Mississippi
Maintained By	St. Louis City Parks
General Condition	Good
Vegetation Condition	Heavy

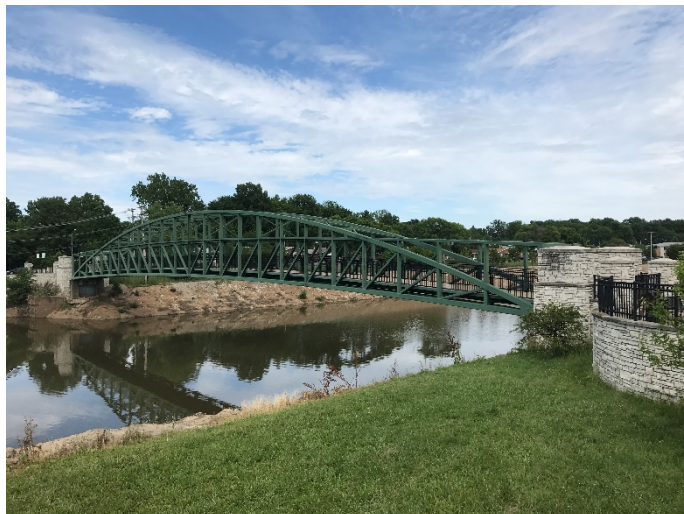
Bridge 19 - River Des Peres Bridge

General Info and Condition	
Install Date	2005
Greenway	River des Peres
Maintained By	St. Louis City Parks
General Condition	Good
Vegetation Condition	Light

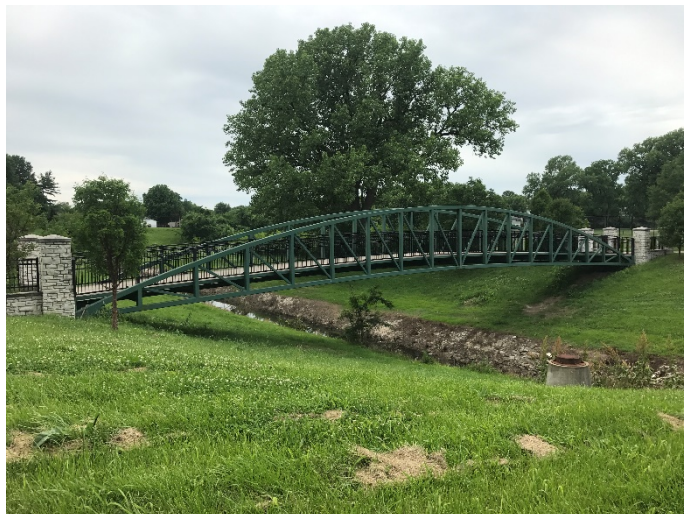
Bridge 20 - River Des Peres Tributary Bridge

General Info and Condition	
Install Date	2005
Greenway	River des Peres
Maintained By	St. Louis City Parks
General Condition	Fair
Vegetation Condition	Moderate

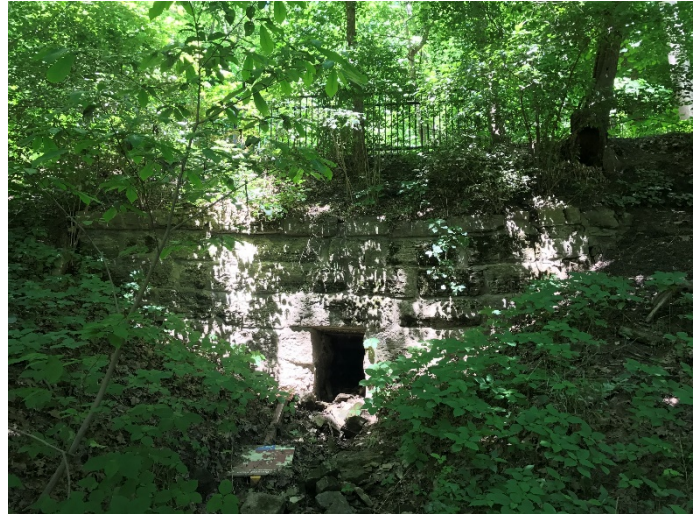
General Info and Condition	
Install Date	Unknown/Mid-Late 1800's
Greenway	Meramec
Maintained By	Wildwood
General Condition	Poor
Vegetation Condition	Moderate

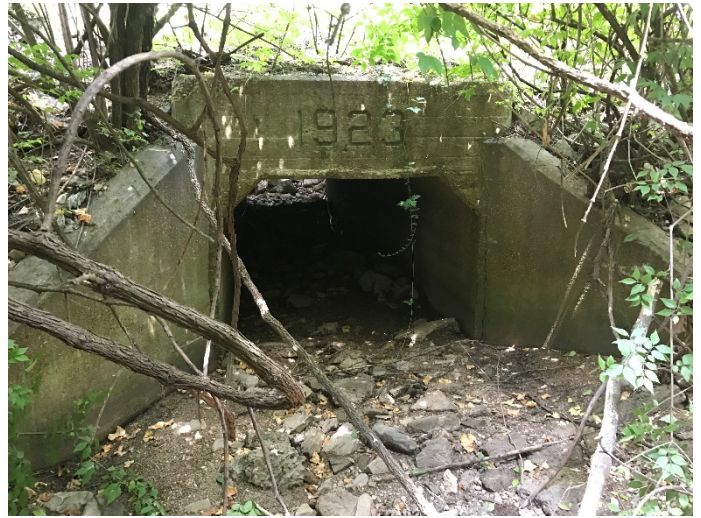
General Info and Condition	
Install Date	1923
Greenway	Gravois
Maintained By	St. Louis County Parks
General Condition	Poor
Vegetation Condition	Moderate

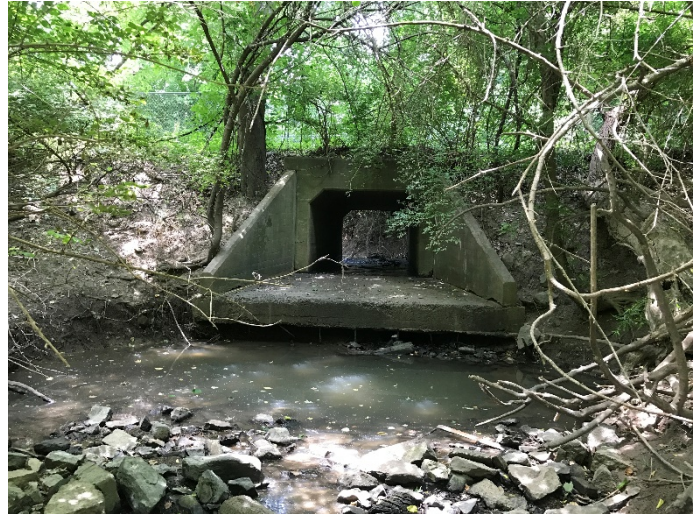
General Info and Condition	
Install Date	1945
Greenway	Gravois
Maintained By	St. Louis County Parks
General Condition	Poor
Vegetation Condition	Heavy

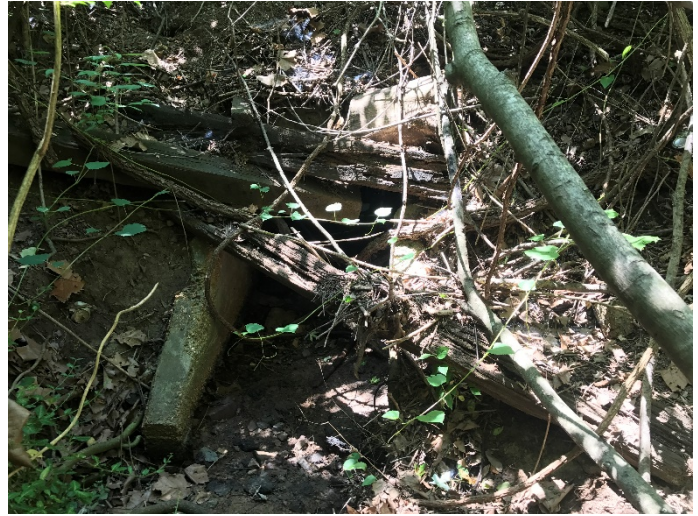
General Info and Condition	
Install Date	1917
Greenway	Gravois
Maintained By	Great Rivers Greenway
General Condition	Poor
Vegetation Condition	Heavy

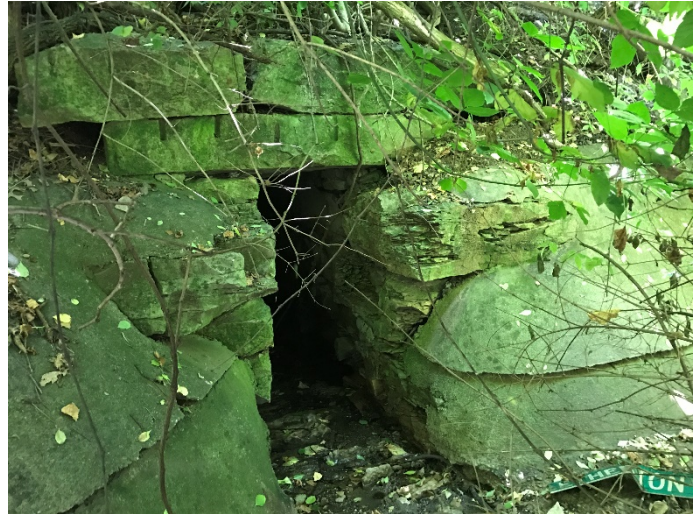
General Info and Condition	
Install Date	Unknown
Greenway	Gravois
Maintained By	Great Rivers Greenway
General Condition	Poor
Vegetation Condition	Moderate

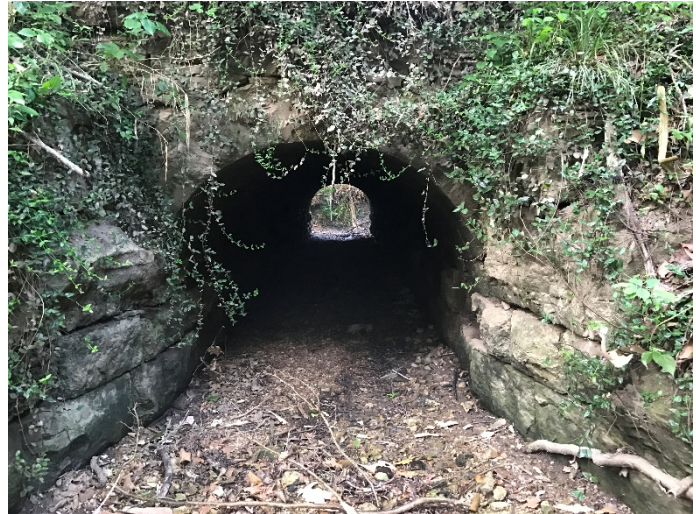
General Info and Condition	
Install Date	Unknown/Mid-Late 1800s
Greenway	Meramec
Maintained By	DNR
General Condition	Poor
Vegetation Condition	Moderate
