Great Rivers Greenway

GIS Bridge Inventory Report

By Christopher Cattron

July 28, 2017

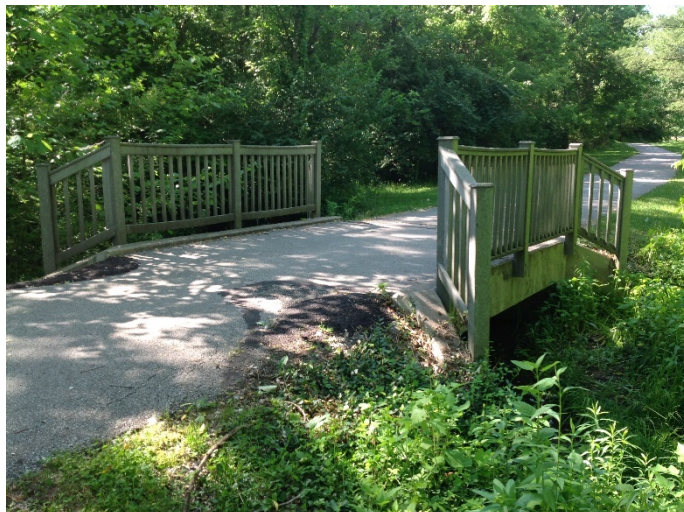
Bridge 3 - St. Vincent County Park Box Culvert

General Info and Condition	
Install Date	2008
Greenway	St. Vincent
Maintained By	St. Louis County Parks
General Condition	Good
Vegetation Condition	Moderate

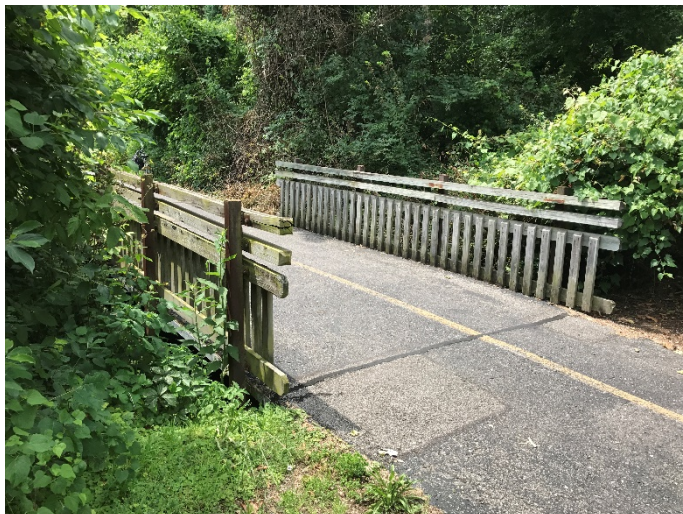
Bridge 12 - Grant's Trail Old Medium-span RR Bridge East

General Info and Condition	
Install Date	Unknown
Greenway	Gravois
Maintained By	St. Louis County Parks
General Condition	Poor
Vegetation Condition	Heavy

Wooden beams and piers with steel girders. Wooden beams and piers with steel girders. Asphalt pavement on corrugated metal decking resting on transverse timber beams on longitudinal steel railway tracks. Abutments are timber sills and gabions. Timber substructure members rotting. Lots of heavy vegetation.

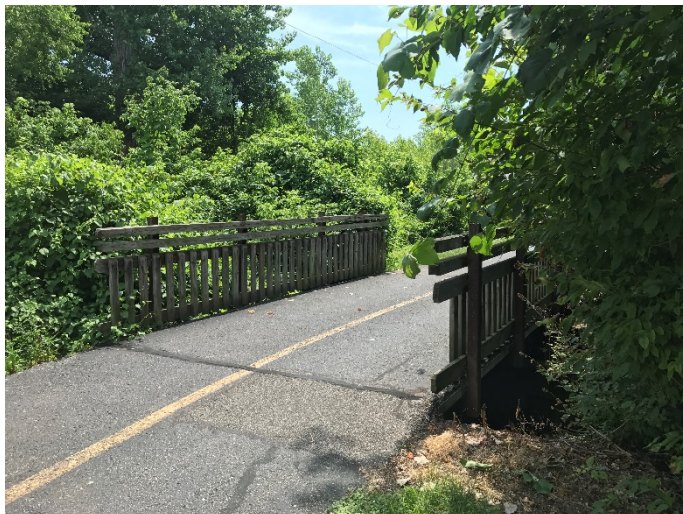
Bridge 13 - Grant's Trail Old Medium-span RR Bridge West

General Info and Condition	
Install Date	Unknown
Greenway	Gravois
Maintained By	St. Louis County Parks
General Condition	Poor
Vegetation Condition	Heavy

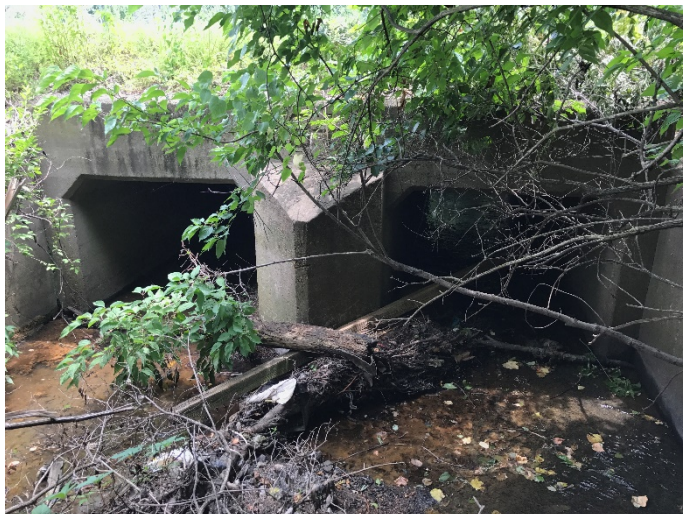
Bridge 16 - Grant's Trail 1944 Double Box Culvert

General Info and Condition	
Install Date	1944
Greenway	Gravois
Maintained By	St. Louis County Parks
General Condition	Fair
Vegetation Condition	Heavy

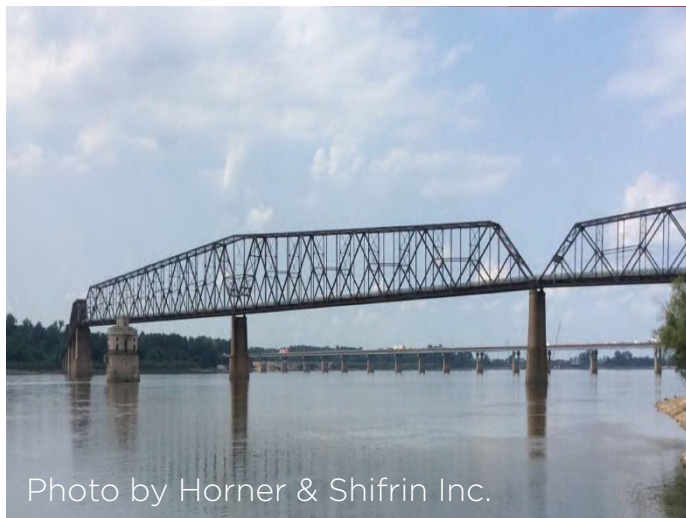
Bridge 18 - Old Chain of Rocks Bridge

General Info and Condition	
Install Date	1929
Greenway	Mississippi
Maintained By	Great Rivers Greenway
General Condition	Fair
Vegetation Condition	Heavy

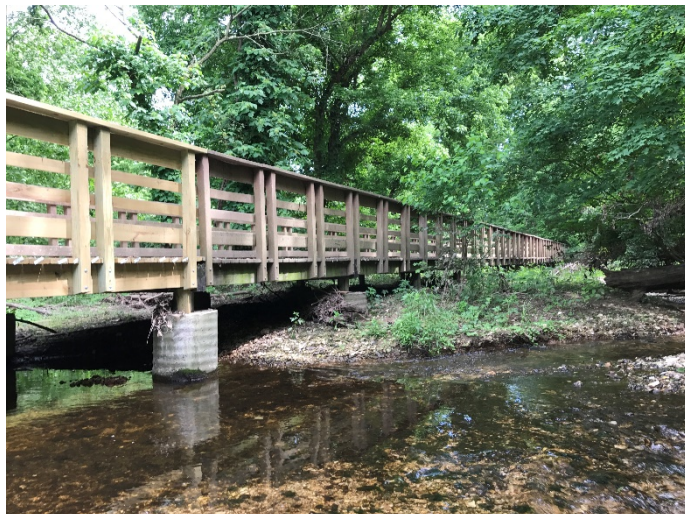
Bridge 21 - Duckett Creek Boardwalk

General Info and Condition	
Install Date	2007
Greenway	Busch
Maintained By	Mo. Research Park
General Condition	Fair
Vegetation Condition	Moderate

The deck is supported by 2x10 timber joists, which are supported by bents made up of 6x12 timber header beams and two 6x6 timber posts. Each post bears on an 8' long, 18" diameter concrete pier. Brush builds up at piers. Some tall, large diameter trees are near the bridge. Lichen grows on bridge. The railing is warped. On August 11, 2016, an ambulance of unknown weight (12,000 lbs according to EMT on the scene) attempted to cross the boardwalk. The boardwalk failed under the load in the vicinity of Spans 3 & 4. Some repairs were made; as a result, some of the deck and railing is regular wood.

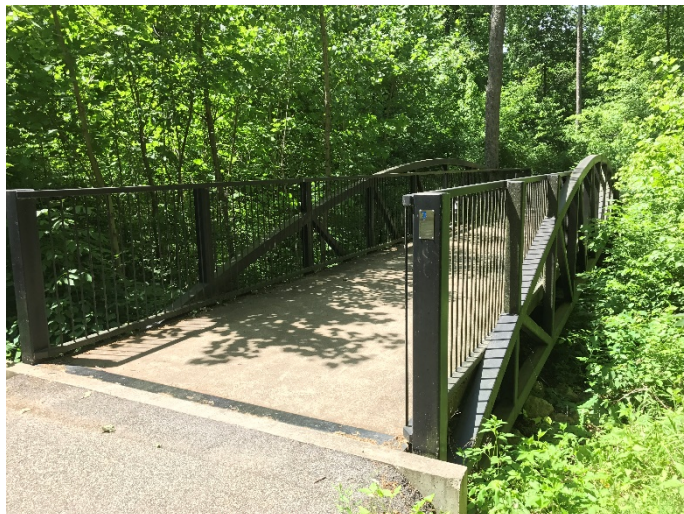
Bridge 22 - Busch 70' Bowstring Bridge

General Info and Condition	
Install Date	2007
Greenway	Busch
Maintained By	Mo. Research Park
General Condition	Good
Vegetation Condition	Heavy

Very tall large diameter tree one foot away from bridge. Thick vegetation grows on sides of bridge and at supports and small vegetation grows under. Nesting insects and birds below bridge. Fair amount of paint wear on members under the deck. Lichen grows on bridge truss and railing. Approaches repaired 2016.

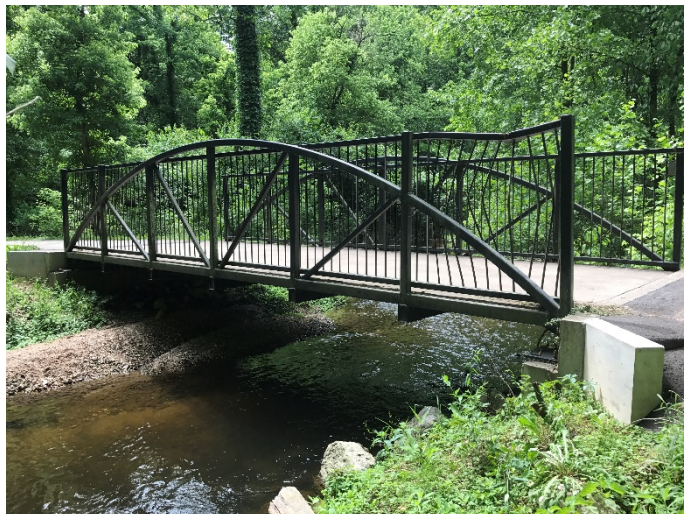
Bridge 23 - Busch 28' Bowstring Bridge

General Info and Condition	
Install Date	2007
Greenway	Busch
Maintained By	Mo. Research Park
General Condition	Good
Vegetation Condition	Light

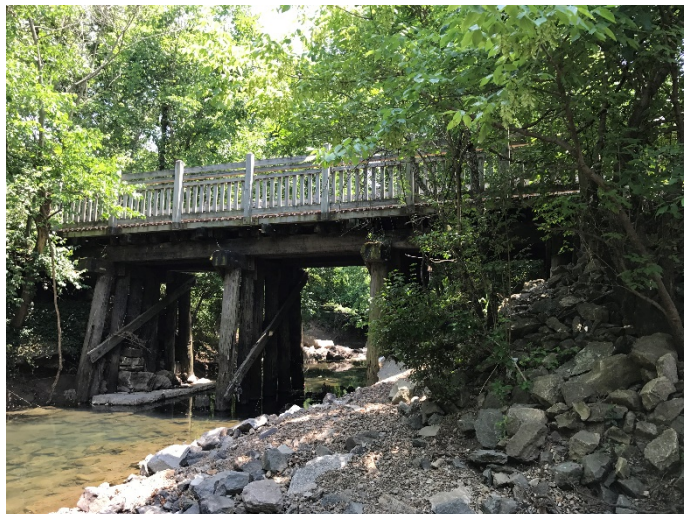
Bridge 24 - Dillman Bridge

General Info and Condition	
Install Date	Unknown
Greenway	Gravois
Maintained By	St. Louis County Parks
General Condition	Poor
Vegetation Condition	Heavy

Wooden beams and piers with steel girders. Asphalt pavement on corrugated metal decking resting on transverse timber beams on longitudinal steel railway tracks. Abutments are timber sills and gabions. Wooden decking appears to be relatively new. Clearance under bridge is about 10 ft.

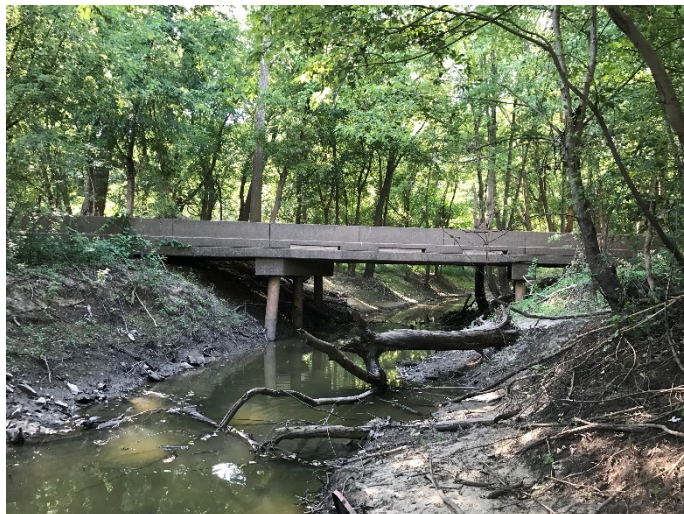
Bridge 25 - Lower Meramec Park Long Span Slab Bridge

General Info and Condition	
Install Date	Unknown
Greenway	Meramec
Maintained By	St. Louis County Parks
General Condition	Fair
Vegetation Condition	Light

Continuous three span concrete slab with integral parapet and curb. Slab built integrally on two bents supported by three round columns. Three rectangular openings are on each side of the bridge through the curbs. These openings are about 64 inches wide and 5 inches tall. The concrete curb on the bridge is about 9.5 inches tall. The concrete railing is an additional 20 inches taller than the curb. In plan view the bridge is shaped like a parallelogram. Bridge appears to be an old vehicular traffic bridge. Some reinforcement is exposed on parapet walls and on side of bents near where it meets the deck.

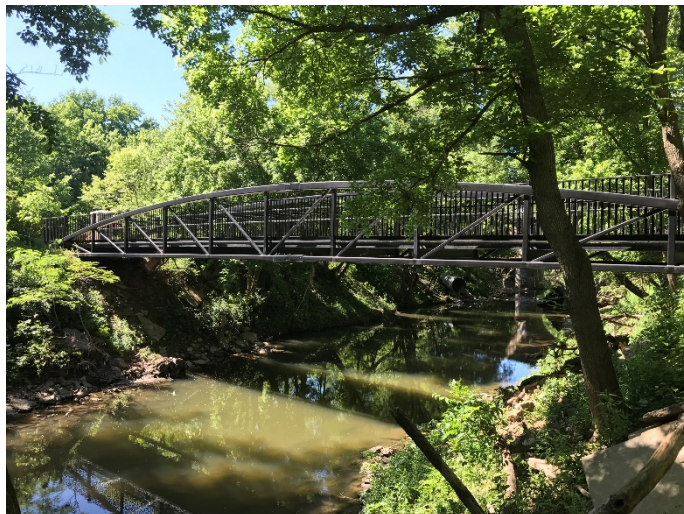
Bridge 26 - Deer Creek Park Pedestrian Bridge

General Info and Condition	
Install Date	2008
Greenway	Shady-Deer
Maintained By	Great Rivers Greenway
General Condition	Good
Vegetation Condition	Moderate

Foam expansion joint at each abutment. Vegetation at supports and side of bridge. Asphalt patches where bridge deck meets path are not flush with deck. About 1 inch lip on west end. Lichen grows on bottom of railing and near end of bridges. Water surface was about 17 ft below deck on 5/25/17. The O&M agreements do not specify which city is responsible for the maintenance of this bridge.

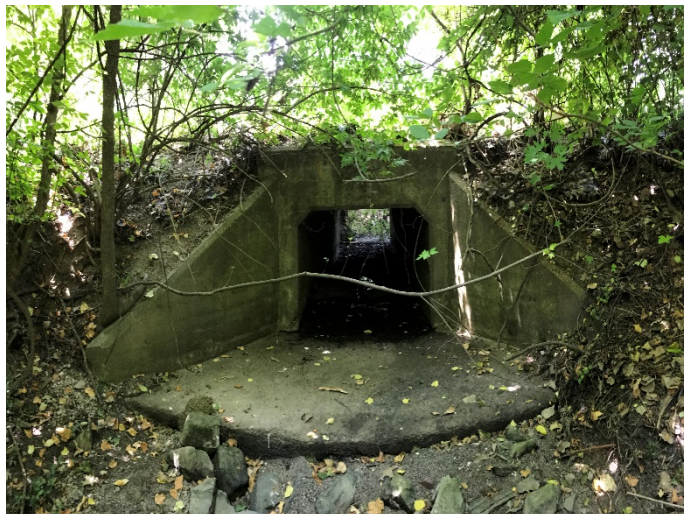
Bridge 27 - Grant's Trail 1945 Box Culvert North

General Info and Condition	
Install Date	1945
Greenway	Gravois
Maintained By	St. Louis County Parks
General Condition	Poor
Vegetation Condition	Heavy

Significant deterioration inside culvert. Lots of exposed reinforcement. Overgrown at openings.

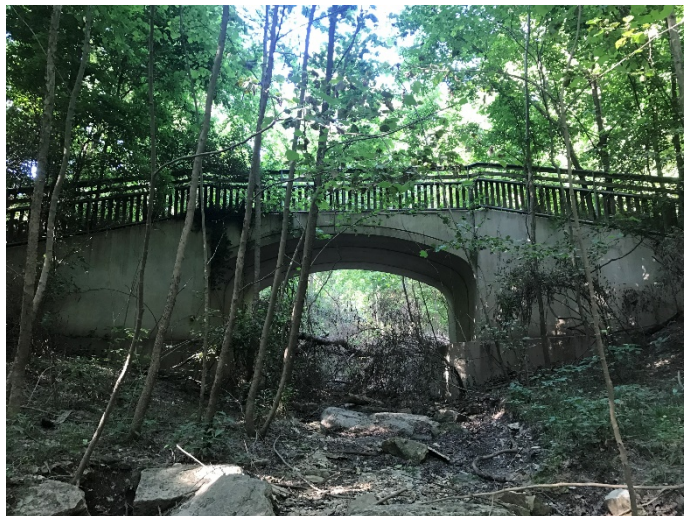
Bridge 28 - East Sherman Beach Park Bridge

General Info and Condition	
Install Date	Unknown
Greenway	Meramec
Maintained By	DNR
General Condition	Good
Vegetation Condition	Heavy

Appears to be a CON/SPAN® Bridge Systems style structure. Wooden railing. Area heavily wooded. Lots of vegetation growing over railing, on structure, etc.

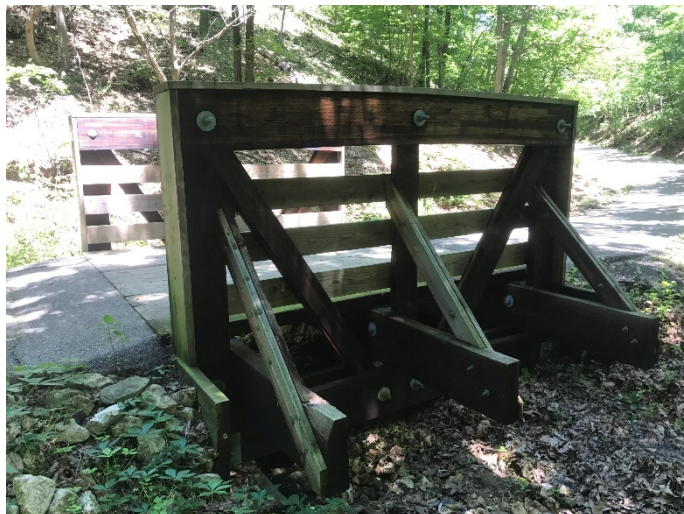
Bridge 29 - Rock Hollow Trail Bridge #1

General Info and Condition	
Install Date	2010
Greenway	Meramec
Maintained By	Wildwood
General Condition	Good
Vegetation Condition	Moderate

Multi-leaf Pratt truss design with lateral stability provided by external knee bracing. Bridge abutments consist of timber sill on gabion basket. Girders 12 inches deep, 2.5 inches wide. Deck 3.5 inches thick. 2.5 feet from the bottom of the girder to the top of the deck. Small crack on outside of girder. Some buildup of sediment, brush, leaves, etc. at supports and area under deck.

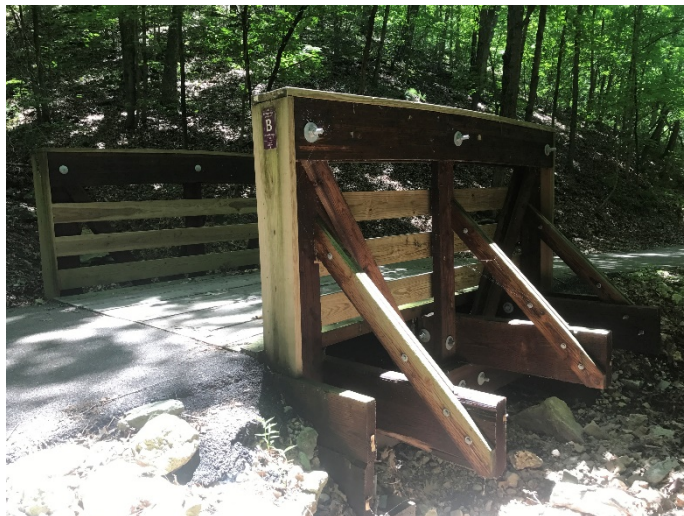
Bridge 30 - Rock Hollow Trail Bridge #2

General Info and Condition	
Install Date	2010
Greenway	Meramec
Maintained By	Wildwood
General Condition	Good
Vegetation Condition	Light

Multi-leaf Pratt truss design with lateral stability provided by external knee bracing. Bridge abutments consist of timber sill on gabion basket. Exterior brace cracked significantly. Supports and area under deck subject to significant buildup of sediment, brush, leaves, etc. Bridge is emergency locator B for the trail.

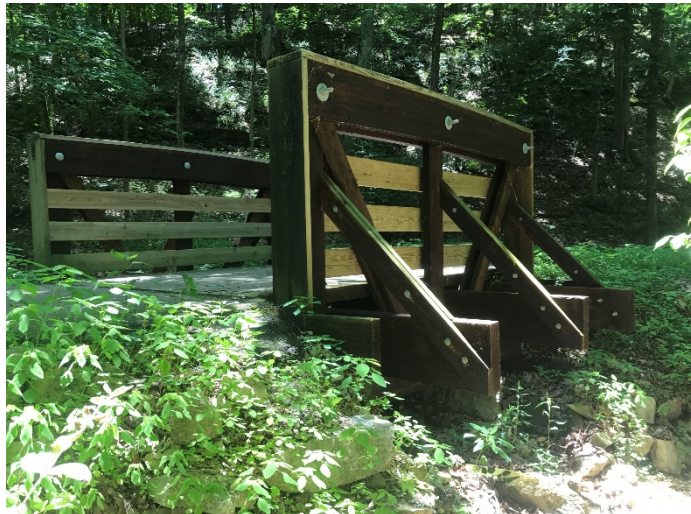
Bridge 31 - Rock Hollow Trail Bridge #3

General Info and Condition	
Install Date	2010
Greenway	Meramec
Maintained By	Wildwood
General Condition	Good
Vegetation Condition	Light

Multi-leaf Pratt truss design with lateral stability provided by external knee bracing. Bridge abutments consist of timber sill on gabion basket. Supports and area under deck subject to significant buildup of sediment, brush, leaves, etc. Some vegetation at sides

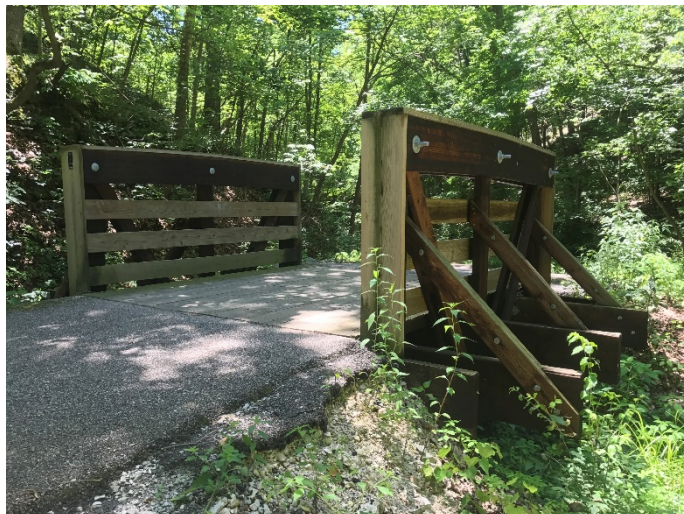
Bridge 32 - Rock Hollow Trail Bridge #4

General Info and Condition	
Install Date	2010
Greenway	Meramec
Maintained By	Wildwood
General Condition	Good
Vegetation Condition	Light

Multi-leaf Pratt truss design with lateral stability provided by external knee bracing. Bridge abutments consist of timber sill on gabion basket. Some buildup of sediment, brush, leaves, etc. at supports and area under deck. Some vegetation under bridge and at sides.

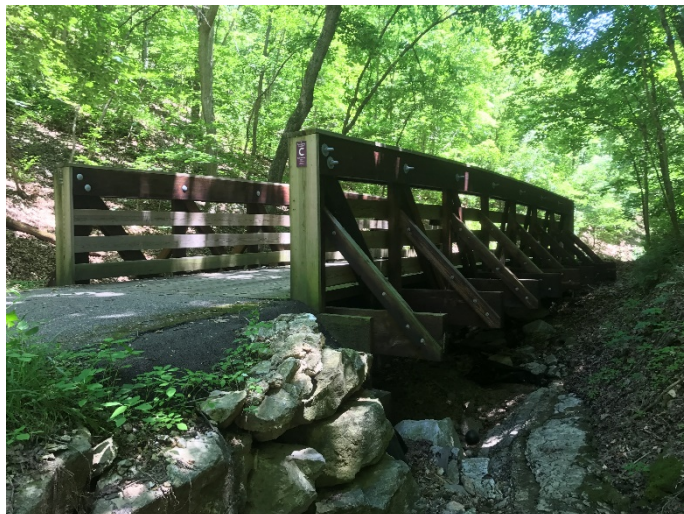
Bridge 33 - Rock Hollow Trail Bridge #5

General Info and Condition	
Install Date	2010
Greenway	Meramec
Maintained By	Wildwood
General Condition	Good
Vegetation Condition	Light

Multi-leaf Pratt truss design with lateral stability provided by external knee bracing. Bridge abutments consist of timber sill on gabion basket. 17 inches from top of girder to top of 4 in deck. Cambered to 1.5 times the dead load deflection plus 1%. Bridge is emergency locator C for the trail. There is an asphalt patch at the side of the approach on the north side of the bridge that is in good condition. Some trees nearby.

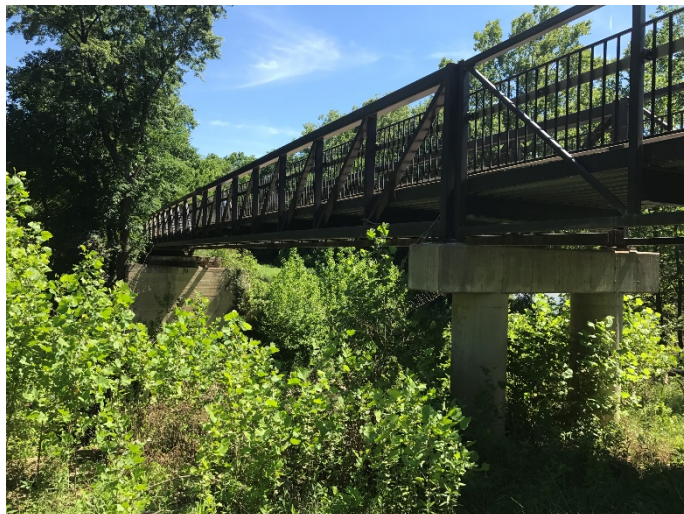
Bridge 34 - Al Foster Memorial Trail Bridge Span #1

General Info and Condition	
Install Date	2011
Greenway	Meramec
Maintained By	Wildwood
General Condition	Good
Vegetation Condition	Moderate

Bridge anchored to abutment at north end, south end is anchored into a pier that is shared with the adjacent bridge. Bridge spans Hamilton-Carr Creek. Ivy, brush, and vegetation growing at sides of bridge, on abutment. Vegetation and small trees grow near bottom of pier. Some large trees nearby. Bridge is two prefab pieces spliced in field. 0.67% slope. Residual camber is 3 5/8". Height above water estimated to be about 28 feet.

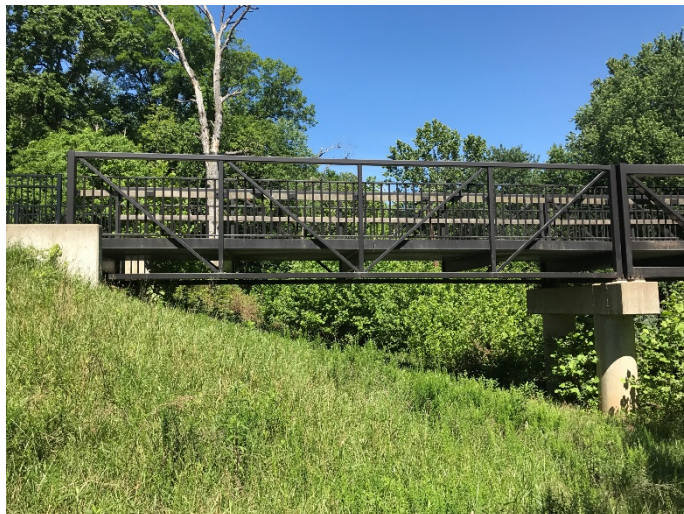
Bridge 35 - Al Foster Memorial Trail Bridge Span #2

General Info and Condition	
Install Date	2011
Greenway	Meramec
Maintained By	Wildwood
General Condition	Good
Vegetation Condition	Moderate

Minor vegetation below bridge. Young tree growing under bridge near abutment. Another small tree growing nearly against bridge at southwest edge of bridge near abutment. Some vegetation and small trees growing near pier. Bridge anchored to abutment at south end. North end of bridge is anchored to pier shared with adjacent bridge. Height estimated to be 15 feet. 0.67% slope. Residual camber is 1/2".

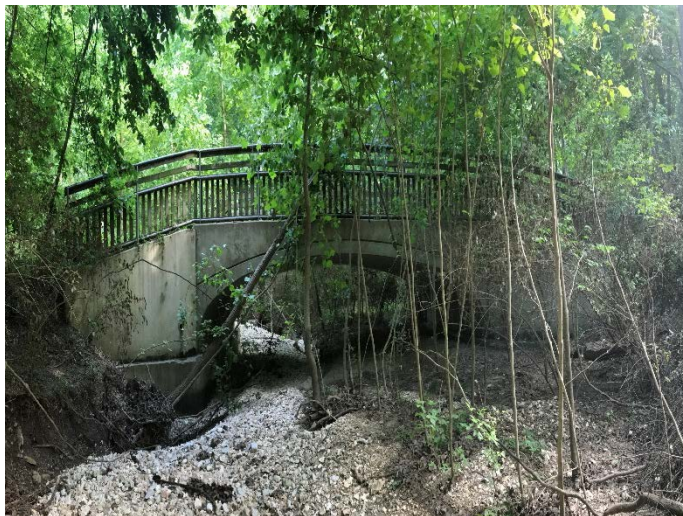
Bridge 36 - West Sherman Beach Park Bridge

General Info and Condition	
Install Date	Unknown
Greenway	Meramec
Maintained By	DNR
General Condition	Good
Vegetation Condition	Heavy

Design is CON/SPAN® Bridge Systems style structure. Lots of vegetation and overgrowth. Significant sediment/rock buildup underneath. Vertical clearance underneath is a minimum of 6' where the sediment is most accumulated.

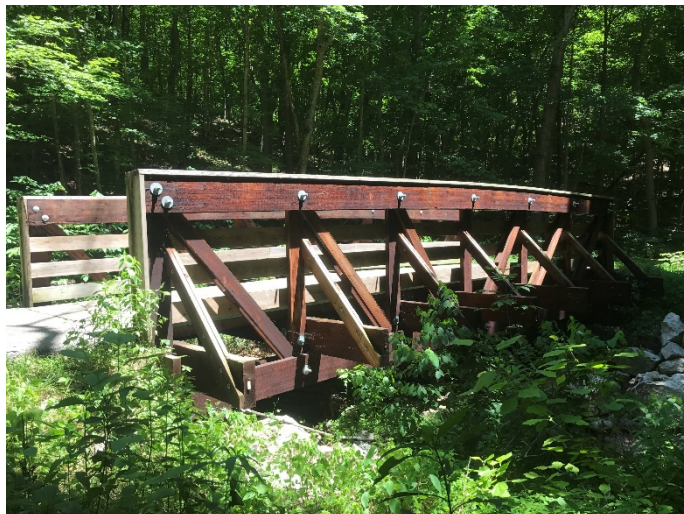
Bridge 37 - Rock Hollow Trail Bridge #6

General Info and Condition	
Install Date	2010
Greenway	Meramec
Maintained By	Wildwood
General Condition	Good
Vegetation Condition	Moderate

Multi-leaf Pratt truss design with lateral stability provided by external knee bracing. Bridge abutments consist of timber sill on gabion basket. Cambered to 1.5 times the dead load deflection plus 1%. Vegetation at sides and under bridge.

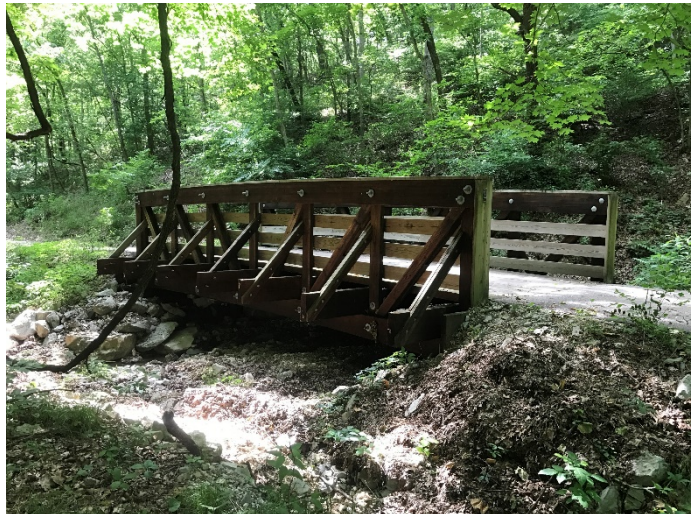
Bridge 38 - Rock Hollow Trail Bridge #7

General Info and Condition	
Install Date	2010
Greenway	Meramec
Maintained By	Wildwood
General Condition	Good
Vegetation Condition	Light

Multi-leaf Pratt truss design with lateral stability provided by external knee bracing. Bridge abutments consist of timber sill on gabion basket. Cambered to 1.5 times the dead load deflection plus 1%.

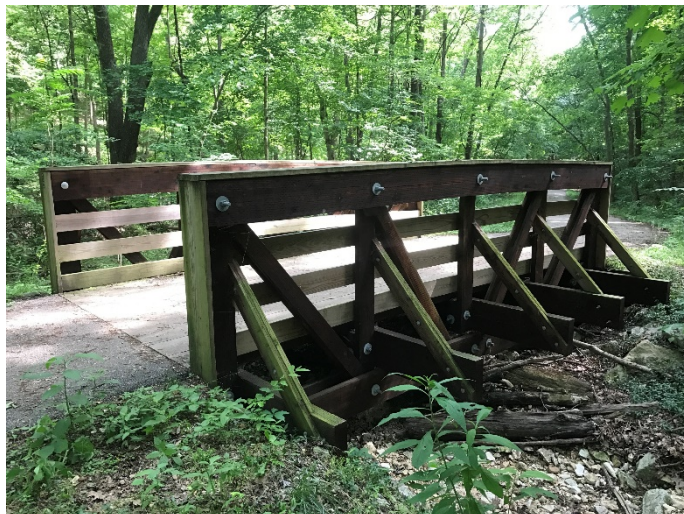
Bridge 39 - Rock Hollow Trail Bridge #8

General Info and Condition	
Install Date	2010
Greenway	Meramec
Maintained By	Wildwood
General Condition	Good
Vegetation Condition	Light

Multi-leaf Pratt truss design with lateral stability provided by external knee bracing. Bridge abutments consist of timber sill on gabion basket. Large tree near bridge. Some large brush caught under bridge.

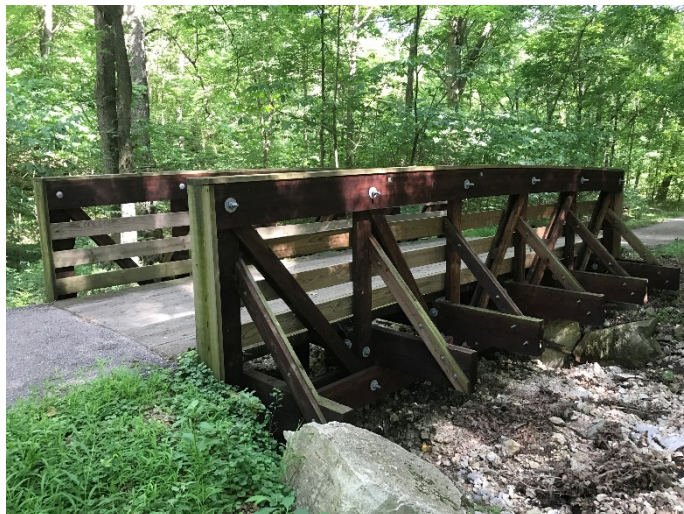
Bridge 40 - Rock Hollow Trail Bridge #9

General Info and Condition	
Install Date	2010
Greenway	Meramec
Maintained By	Wildwood
General Condition	Good
Vegetation Condition	Light

Multi-leaf Pratt truss design with lateral stability provided by external knee bracing. Bridge abutments consist of timber sill on gabion basket.

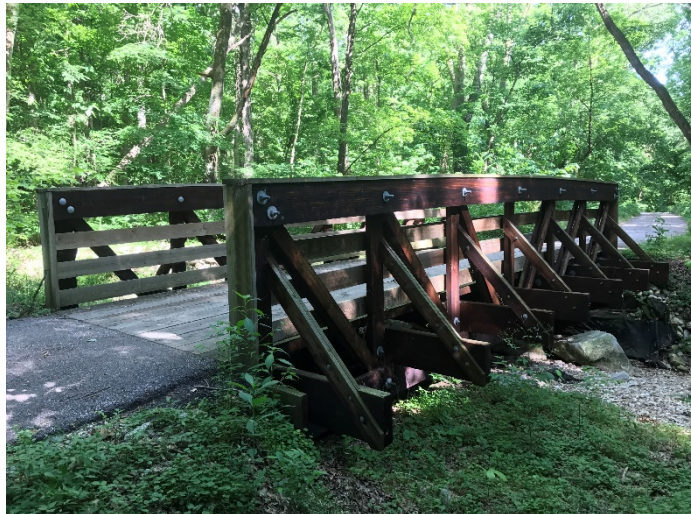
Bridge 41 - Rock Hollow Trail Bridge #10

General Info and Condition	
Install Date	2010
Greenway	Meramec
Maintained By	Wildwood
General Condition	Good
Vegetation Condition	Light

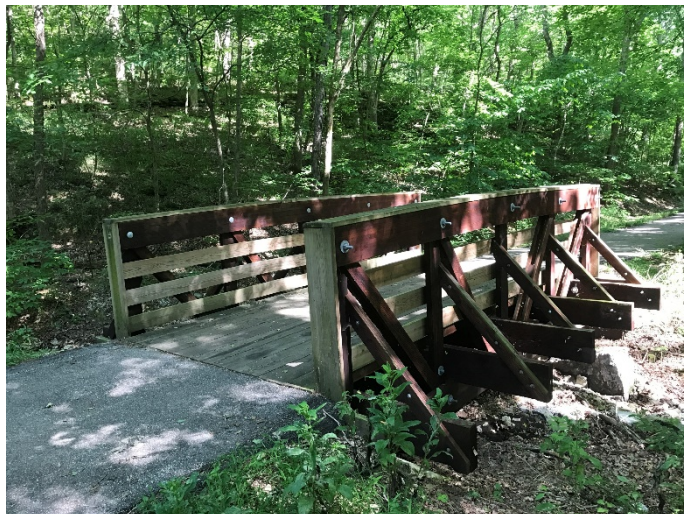
Bridge 42 - Rock Hollow Trail Bridge #11

General Info and Condition	
Install Date	2010
Greenway	Meramec
Maintained By	Wildwood
General Condition	Good
Vegetation Condition	Light

Multi-leaf Pratt truss design with lateral stability provided by external knee bracing. Bridge abutments consist of timber sill on gabion basket. Some buildup of sediment, brush, leaves, etc. at supports and area under deck.

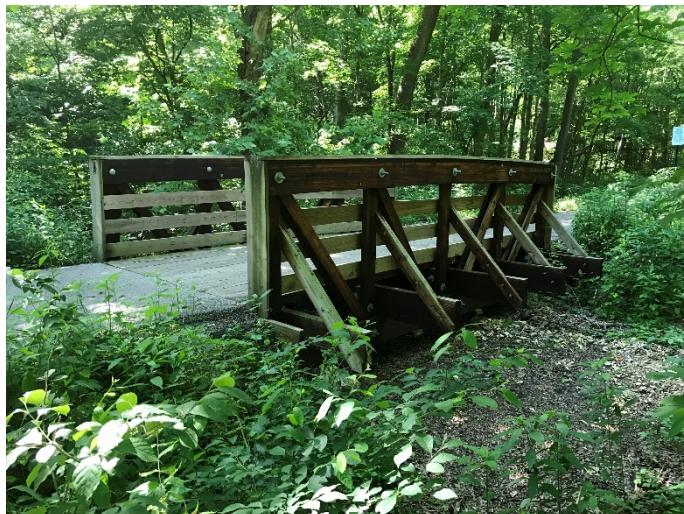
Bridge 43 - Rock Hollow Trail Bridge #12

General Info and Condition	
Install Date	2010
Greenway	Meramec
Maintained By	Wildwood
General Condition	Good
Vegetation Condition	Light

Multi-leaf Pratt truss design with lateral stability provided by external knee bracing. Bridge abutments consist of timber sill on gabion basket. Some buildup of sediment, brush, leaves, etc. at supports and area under deck.

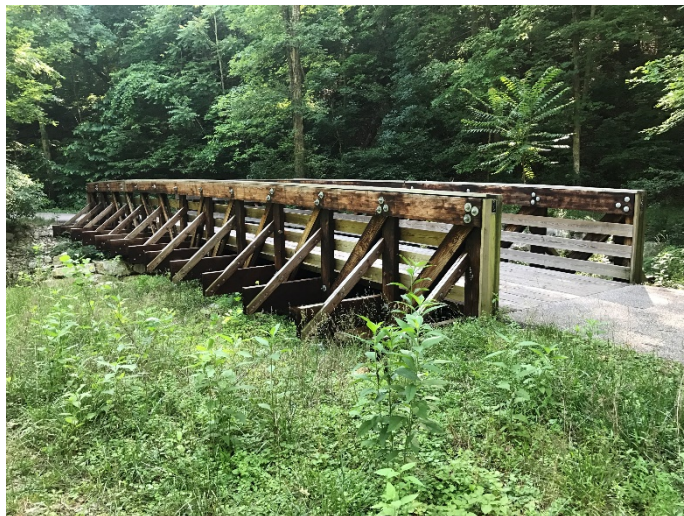
Bridge 44 - Rock Hollow Trail Bridge #13

General Info and Condition	
Install Date	2010
Greenway	Meramec
Maintained By	Wildwood
General Condition	Good
Vegetation Condition	Light

Multi-leaf Pratt truss design with lateral stability provided by external knee bracing. Bridge abutments consist of timber sill on gabion basket. Some vegetation at side of bridge. A few trees nearby. Bridge is emergency locator G for the trail.

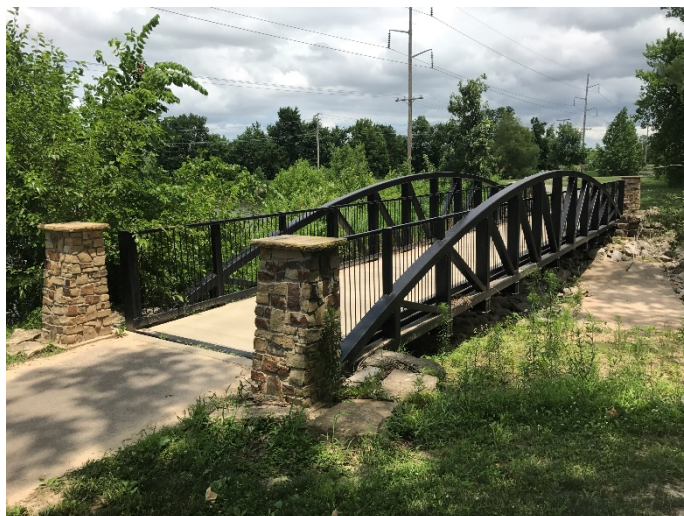
Bridge 45 - Vantage Park Pedestrian Bridge

General Info and Condition	
Install Date	2013
Greenway	Dardenne
Maintained By	Cottleville
General Condition	Good
Vegetation Condition	Light

The supports at the ends of the bridge were covered or submerged in sediment and brush during site visit. Bridge adjacent to Vantage Park lake. Spans overflow channel for the lake. Some light vegetation near bridge and under bridge.

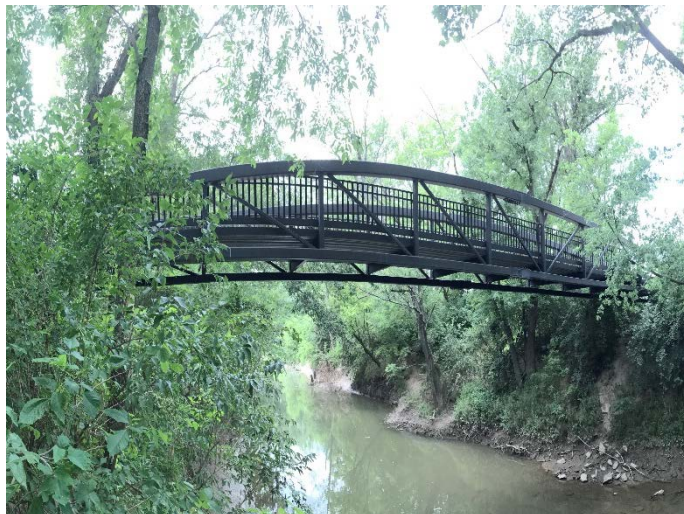
Bridge 46 - Legacy Park to Vantage Park Bridge

General Info and Condition	
Install Date	2009
Greenway	Dardenne
Maintained By	Cottleville
General Condition	Good
Vegetation Condition	Moderate

Bridge is about 19 to 21 feet above water surface. Some vegetation grows under and at the sides of the bridge. Foam expansion joint at abutments.

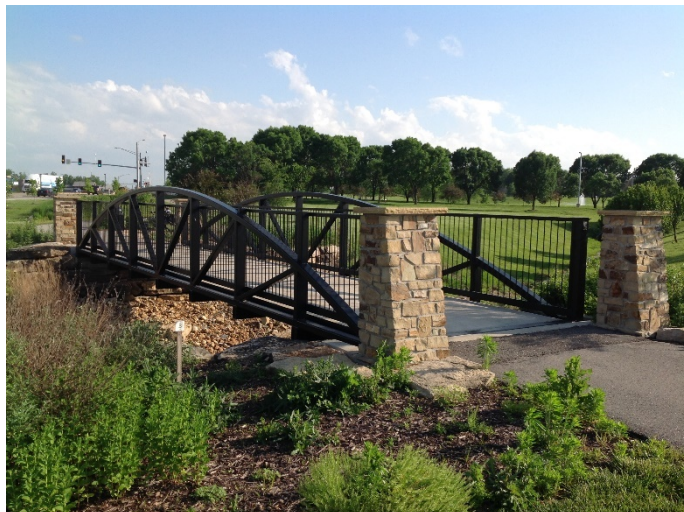
Bridge 47 - St. Charles Community College Bridge

General Info and Condition	
Install Date	2013
Greenway	Dardenne
Maintained By	St. Charles Comm. College
General Condition	Good
Vegetation Condition	None

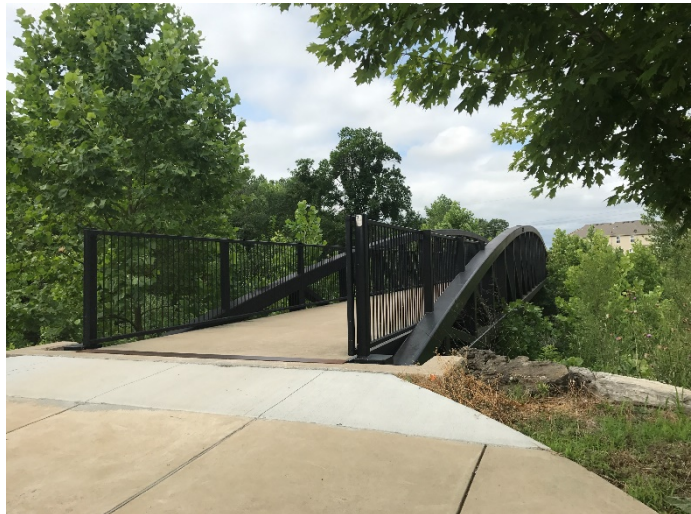
Bridge 48 - Rabbit Run Park Dardenne Creek Bridge

General Info and Condition	
Install Date	2008
Greenway	Dardenne
Maintained By	St. Peters
General Condition	Good
Vegetation Condition	Moderate

Bridge deck was approximately 30 feet above the water surface of the creek on 5/17/17. Where the bridge deck meets the abutment, there is relatively new concrete on both sides of the bridge. On the west side of the bridge there is some exposed steel reinforcement (see pictures). There is vegetation growing at both ends of the bridge and some underneath (though the vegetation underneath is not close to the bridge).

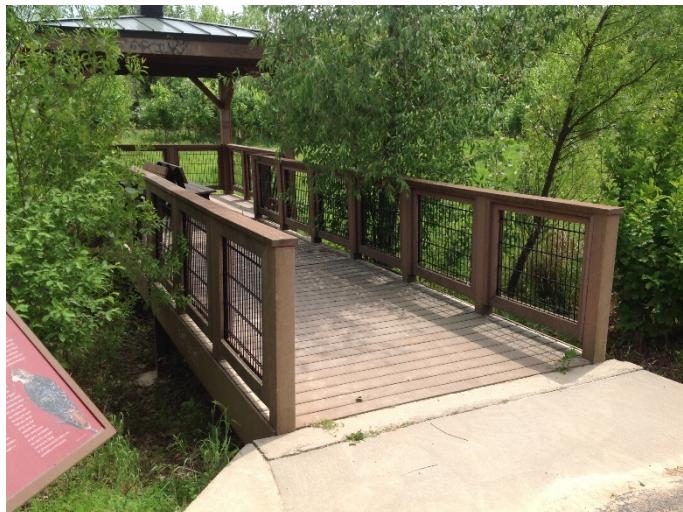
Bridge 49 - Bridge to Rabbit Run Prairie Overlook

General Info and Condition	
Install Date	2008
Greenway	Dardenne
Maintained By	St. Peters
General Condition	Good
Vegetation Condition	Heavy

Two spans on concrete abutment at west end, 2 wood columns on concrete footings at the mid-section of the bridge, and second span runs into an elevated wooden pavilion that is supported by four wooden columns on concrete footings at its corners. Short bridge boardwalk leads to wooden overlook structure with two benches. Vegetation grows around and underneath bridge and bridge is likely to be effected by flooding.

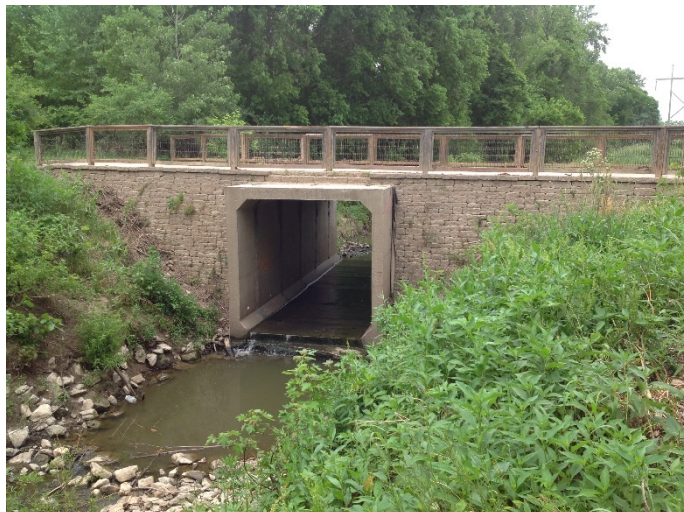
Bridge 50 - Rabbit Run Culvert C-2

General Info and Condition	
Install Date	2008
Greenway	Dardenne
Maintained By	St. Peters
General Condition	Good
Vegetation Condition	Light

Wood railing in fair condition. An estimated 10 missing decorative masonry stones along side retaining walls. About three very minor laterally cracks (less than an eighth of an inch thick) cracks that run from one side of the bridge to the other. Numerous small scarps are visible near the downstream from the bridge. (Pictures show up and downstream conditions). Cannot legibly read it, but something like "CMCC 7-89?-08-0784-00-64??" is on the face of each opening.

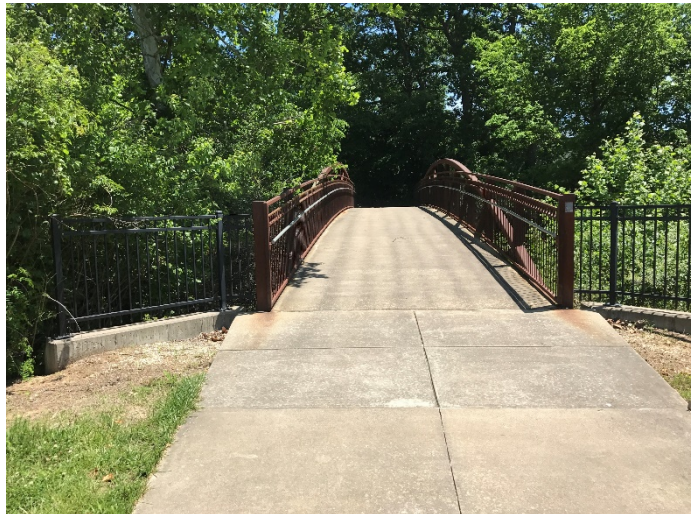
Bridge 51 - BaratHaven Long Bridge

General Info and Condition	
Install Date	2006
Greenway	Dardenne
Maintained By	Dardenne Prarie
General Condition	Good
Vegetation Condition	Heavy

Winged retaining wall at each end of bridge. Leaves, dirt, and other debris builds up at supports. Soil erosion at east abutment. Concrete shows some signs of weathering and staining due to weathered finish of truss structure.

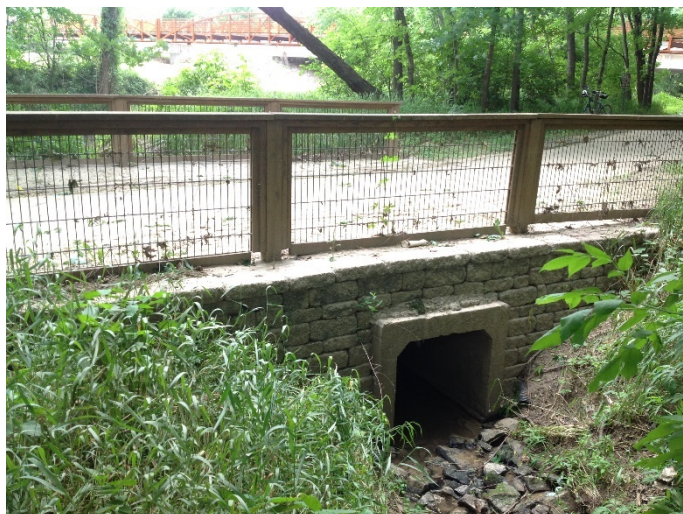
Bridge 52 - Rabbit Run Culvert C-5

General Info and Condition	
Install Date	2008
Greenway	Dardenne
Maintained By	St. Peters
General Condition	Good
Vegetation Condition	Moderate

Not fully legible, but something like "CMCC 8-4-08 C78 254" is carved on the face at each opening. Some light vegetation nearby.

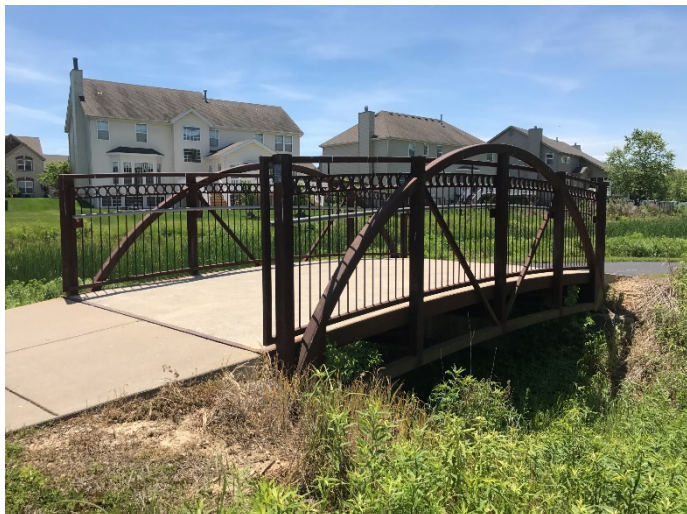
Bridge 53 - BaratHaven Short Bridge

General Info and Condition	
Install Date	2006
Greenway	Dardenne
Maintained By	Dardenne Prarie
General Condition	Good
Vegetation Condition	Light

Vegetation grows under bridge and at supports. Bridge spans floodplain/ephemeral stream?.

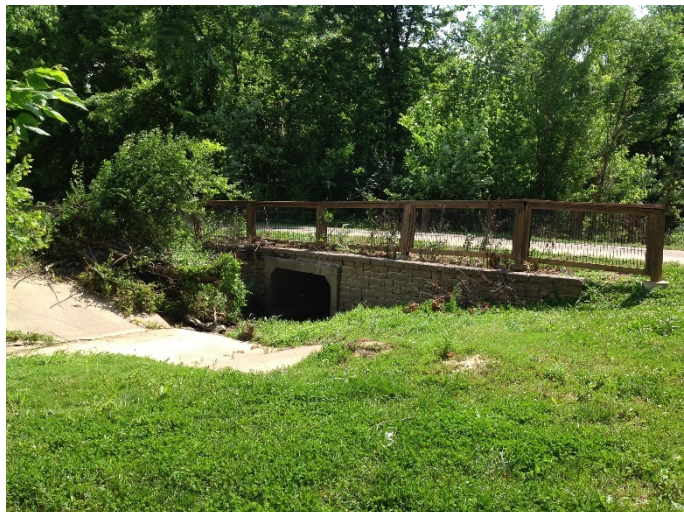
Bridge 54 - Rabbit Run Culvert C-4

General Info and Condition	
Install Date	2008
Greenway	Dardenne
Maintained By	St. Peters
General Condition	Good
Vegetation Condition	Moderate

Vegetation grows against railing on both sides of bridge. This box culvert is adjacent to retaining pond for nearby neighborhood.

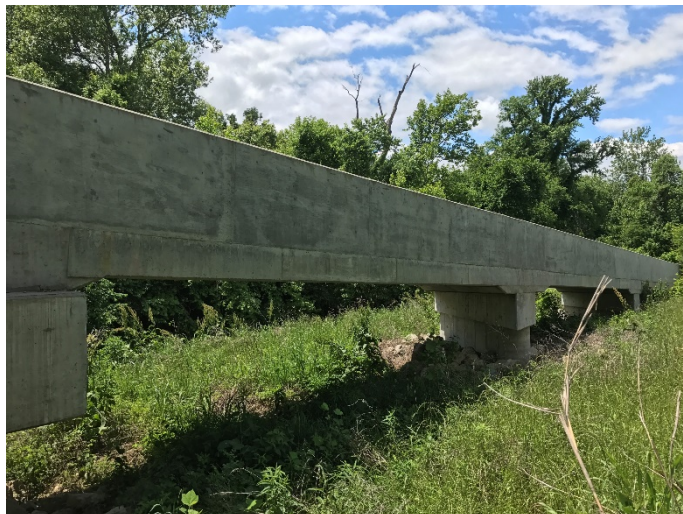
Bridge 55 - McKelvey Woods Trail Concrete Bridge

General Info and Condition	
Install Date	2013
Greenway	Fee Fee
Maintained By	Maryland Heights
General Condition	Good
Vegetation Condition	Light

Thick low vegetation grows under bridge. Bridge slope 4.87%. Large diameter rock/riprap below bridge as well. Bridge serves as support for adjacent truss bridge.

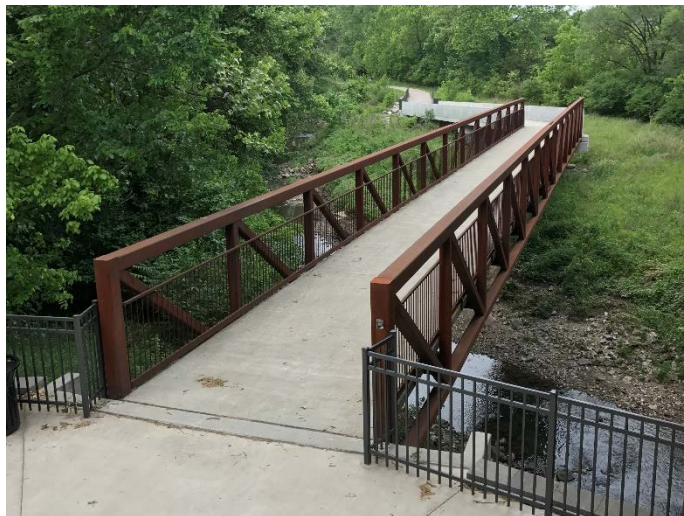
Bridge 56 - McKelvey Woods Trail Long Span Pedestrian Bridge

General Info and Condition	
Install Date	2013
Greenway	Fee Free
Maintained By	Maryland Heights
General Condition	Good
Vegetation Condition	Light

Abutment on south end is flush with an embankment retaining structure that the trail travels along underneath the overpass above. Abutment on north end of bridge is concrete pier that supports this truss bridge and the adjacent concrete bridge. Bridge slope is 1.73%. Thin vegetation grows near bridge. Geocache located on bridge. One small tree grows slightly over bridge.

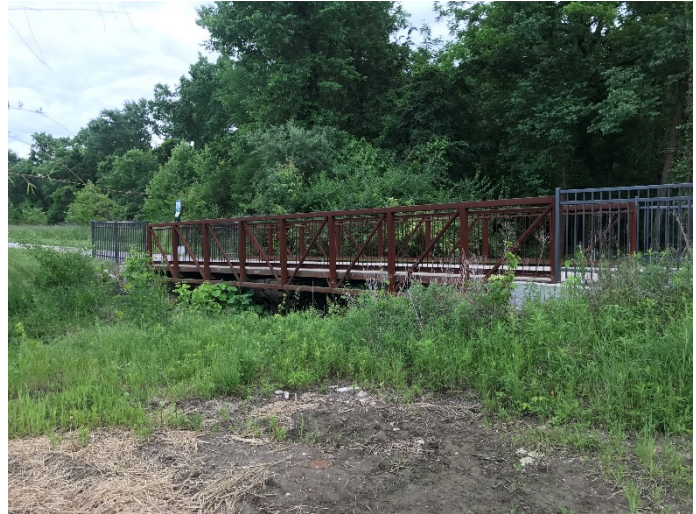
Bridge 57 - McKelvey Woods Trail Short Span Pedestrian Bridge

General Info and Condition	
Install Date	2013
Greenway	Fee Fee
Maintained By	Maryland Heights
General Condition	Good
Vegetation Condition	Moderate

Vegetation under and sides. Some rust on underside of galvanized steel deck pan. 2.92% slope on bridge.

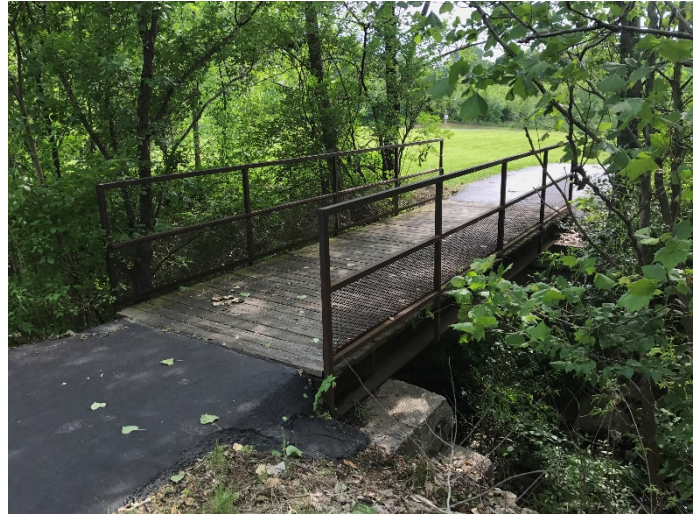
Bridge 58 - Fox Hill Park Trail Bridge

General Info and Condition	
Install Date	Unknown/Pre-2008
Greenway	Boschert
Maintained By	St. Charles
General Condition	Fair
Vegetation Condition	Moderate

Wooden deck supported by a combination of steel and wood girders. Bridge deck surface is 8 ft from bottom of creek at center of span. Distance from decking surface to bottom of steel girders is 15 inches. Bridge is supported by concrete abutments poured on a retaining structure made of recycled concrete blocks. Steel to steel connections are welded. Wood to steel connections are bolted. Steel railing is meshed at the lower half and open at the upper half (see pictures). Insects and birds nest underneath the bridge on the flanges of the I beams and among the girders. Also beneath the bridge, some reinforcing wire is exposed on the recycled concrete blocks that form the face of the abutments. The clear span between the two supports is just over 15 feet. Thick, fairly mature vegetation grows along creek and banks, against, under, and over bridge.

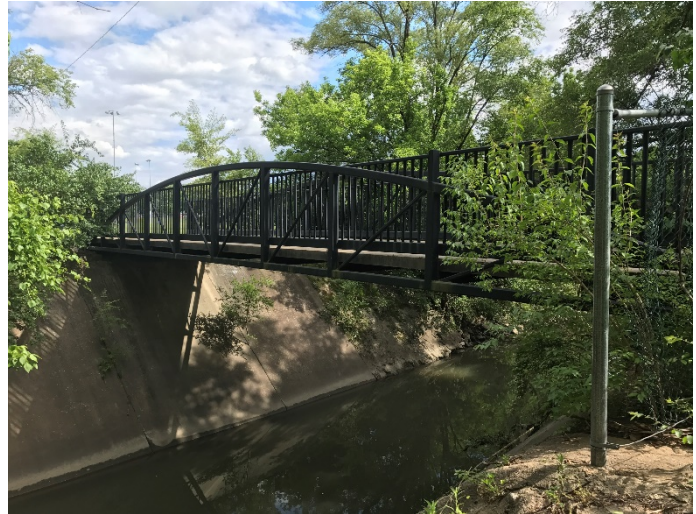
Bridge 59 - Cold Water Creek Pedestrian Bridge

General Info and Condition	
Install Date	2005
Greenway	Sunset
Maintained By	Florissant
General Condition	Fair
Vegetation Condition	Heavy

Quite a bit of graffiti and vandalism. Load posting vandalized at west end of bridge. Lichen growing at NW end of bridge. Thick vegetation grows at sides of bridge near abutment. Sloped concrete wall at each abutment slopes down to Cold Water Creek below.

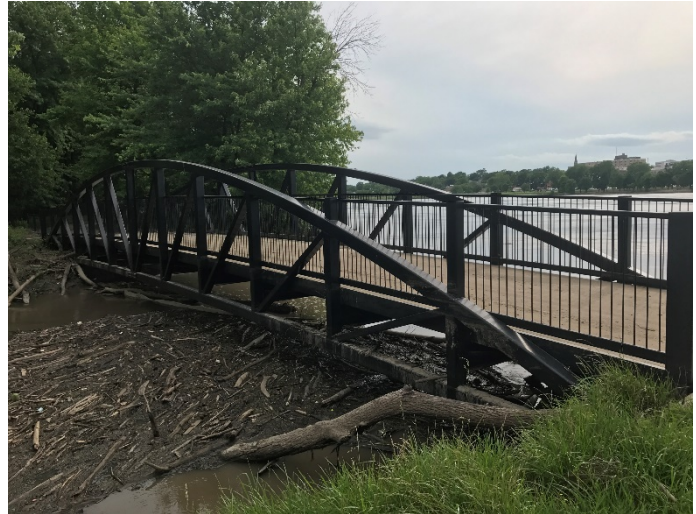
Bridge 60 - Riverwoods Trail Pedestrian Bridge

General Info and Condition	
Install Date	2006
Greenway	Missouri
Maintained By	Bridgeton
General Condition	Good
Vegetation Condition	Light

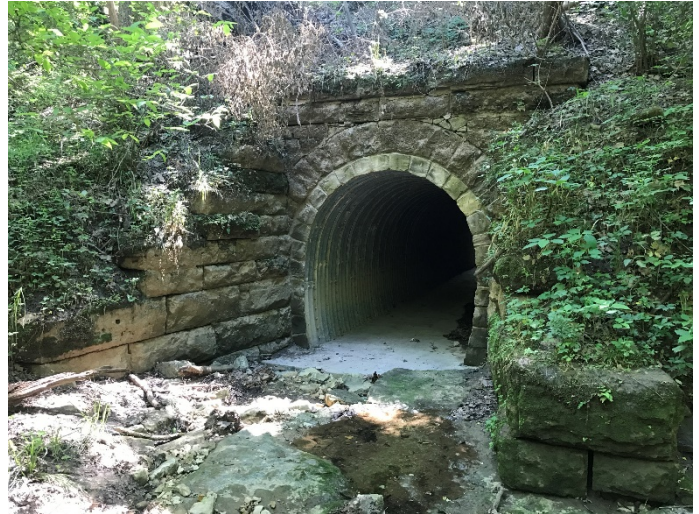
Bridge 62 - Al Foster Memorial Trail Stone Arch Culvert

General Info and Condition	
Install Date	Mid-Late 1800s— Rehabilitated 2011
Greenway	Meramec
Maintained By	DNR
General Condition	Good
Vegetation Condition	Light

Stone arch culvert with retrofit concrete box culvert with slip line steel lining. The existing stone arch culvert was likely constructed in the mid-1800s along with the original embankment for the railroad. Trail is about 20 ft above the top of the tunnel. There is minor sediment buildup in the culvert. 2009 report by Access Engineering, LLC. outlines details regarding in-situ conditions and rehabilitation options. Culvert was considered unsafe to cross before the 2011 structural rehabilitation.

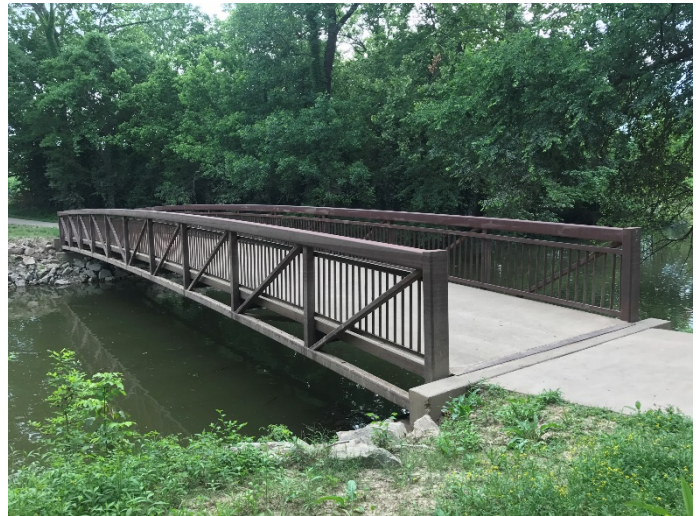
Bridge 63 - George Winter Park Bridge

General Info and Condition	
Install Date	2005
Greenway	Meramec
Maintained By	St. Louis County Parks
General Condition	Good
Vegetation Condition	None

Bridge was installed in Fall 2005 on shallow spread type footing. A storm event in 2008 resulted in the erosion of the bank material under the northern footing. The resulting erosion under the footing caused the bridge and footing to side into the creek. The footings and abutments were replaced and repairs were made in 2011. Bridge deck about 8 ft above water surface on 6/7/2017.
