Great Rivers Greenway

GIS Bridge Inventory Report

By Christopher Cattron

July 28, 2017

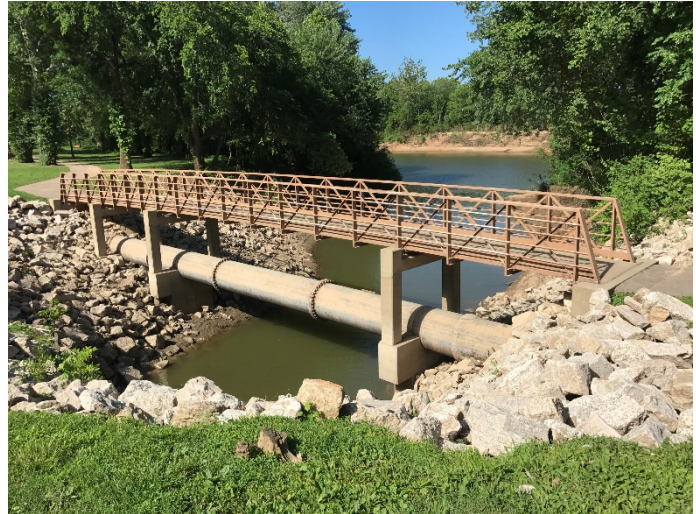
Bridge 64 - Meramec Double Pratt Truss Pedestrian Bridge

General Info and Condition	
Install Date	Unknown
Greenway	Meramec
Maintained By	St. Louis County Parks
General Condition	Good
Vegetation Condition	None

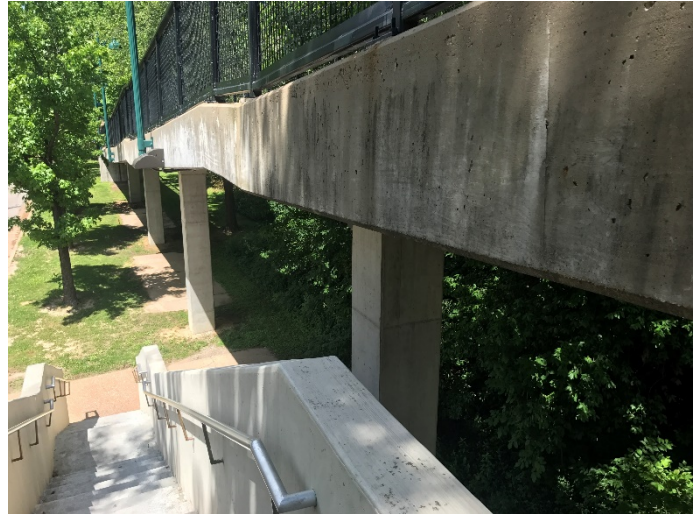
Bridge 71 - Ramp to Forest Park Pkwy Pedestrian Bridge to Washington University Campus

General Info and Condition	
Install Date	2004
Greenway	Centennial
Maintained By	Washington Univ.
General Condition	Good
Vegetation Condition	Moderate

Ramp is planned to be removed and replaced along with adjacent bridge over Forest Park Pkwy. About 210 ft from bottom of north abutment to bottom of southernmost pier (shared with adjacent bridge). Many tall moderate diameter trees within ten feet of bridge. Bridge ramp about 291 ft long diagonal. Ramp max height about 24.5 ft.

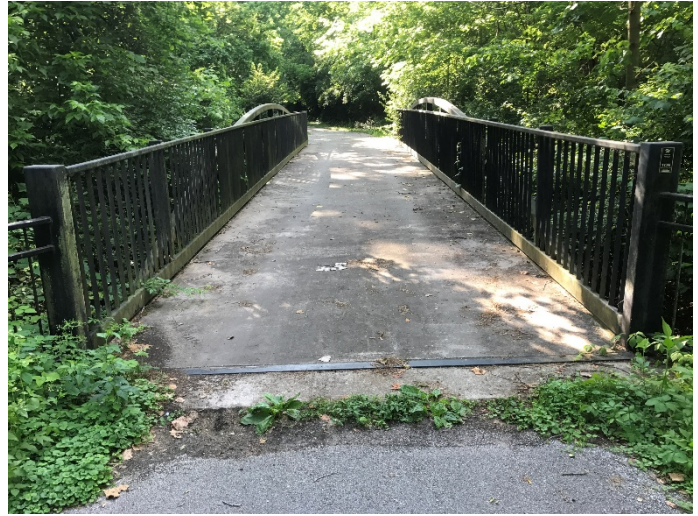
Bridge 72 - Truman Park Pedestrian Bridge

General Info and Condition	
Install Date	2005
Greenway	Missouri
Maintained By	Hazelwood
General Condition	Fair
Vegetation Condition	Heavy

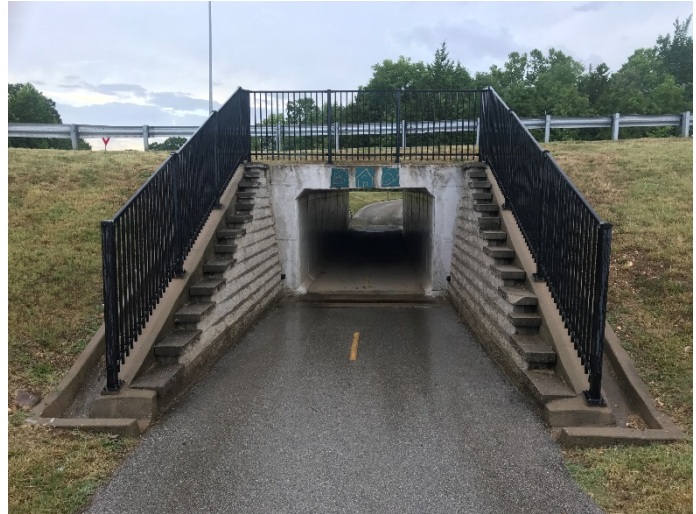
Bridge 76 - Hamilton Carr Pedestrian Tunnel under Old State Road

General Info and Condition	
Install Date	2008
Greenway	Western
Maintained By	Wildwood
General Condition	Good
Vegetation Condition	None

Combination of pre-cast concrete segments for the barrel of the underpass and cast-in-place concrete headwalls at each end. The wing walls consist of four modular block retaining walls, one at each corner of the structure. The barrel of the underpass has a 10' wide by 8' tall opening and consists of twelve box sections, each one being 5' long for a total length of approximately 60'. The side walls of each box section are 9" thick, the top slab is 11" thick and the floor slab is 10" thick. The cast-in-place headwalls are constructed of 12" thick reinforced concrete. Trench drains are at each end of the underpass to provide for drainage. A perforated draitile also runs the entire length of each side of the underpass. These drainage items drain to daylight in the drainage ditch to the southwest of the underpass structure. The trail leading to the underpass is constructed of 6" thick asphalt on top of 4" of compacted base rock. There is a layer of asphalt on the floor of the underpass structure approximately 1.5" thick to provide for a smooth riding surface. Rusted bolted plates on ceiling.

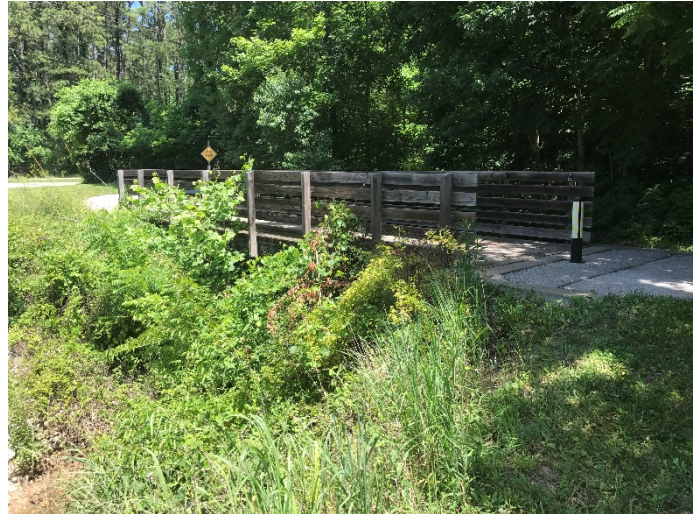
Bridge 77 - Hamilton Carr Trail Wooden Bridge

General Info and Condition	
Install Date	Unknown
Greenway	Western
Maintained By	Wildwood
General Condition	Good
Vegetation Condition	Moderate

Girders 28" deep, 5 1/8" wide. Four longitudinal girders. Geocache under bridge. Birds and insects nest below. Tree growing underneath. Vegetation at sides of bridge. Many bolted connections at abutments in good condition. Railing is warped slightly.

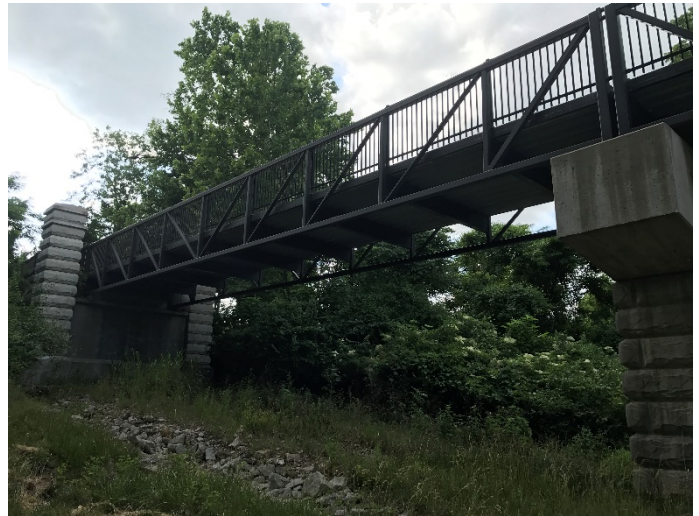
Bridge 81 - Jefferson Barracks Pedestrian Bridge Span #1

General Info and Condition	
Install Date	2011
Greenway	Mississippi
Maintained By	St. Louis County Parks
General Condition	Good
Vegetation Condition	Light

Span 1 of 10. 2.5% slope. On project plans, 454.76 ft elevation at west end, 453.01 elevation at east end. Trees grow near bridge. Vegetation and lots of leaves and debris accumulated at supports at west end of bridge.

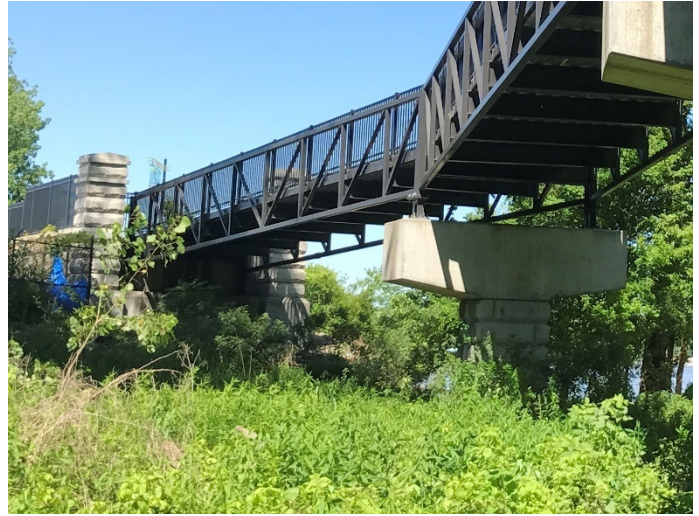
Bridge 90 - Jefferson Barracks Pedestrian Bridge Span #10

General Info and Condition	
Install Date	2011
Greenway	Mississippi
Maintained By	St. Louis County Parks
General Condition	Good
Vegetation Condition	Moderate

Span 10 of 10. Vegetation grows underneath bridge and at bents. Some trees near bridge. Some vegetation and leaves/debris at east end of bridge at supports.

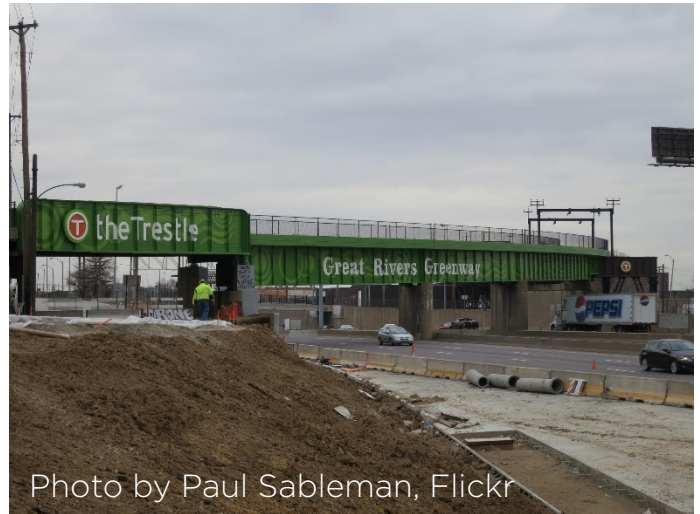
Bridge 92 - The Trestle

General Info and Condition	
Install Date	1930
Greenway	Confluence
Maintained By	Great Rivers Greenway
General Condition	Fair
Vegetation Condition	Varies

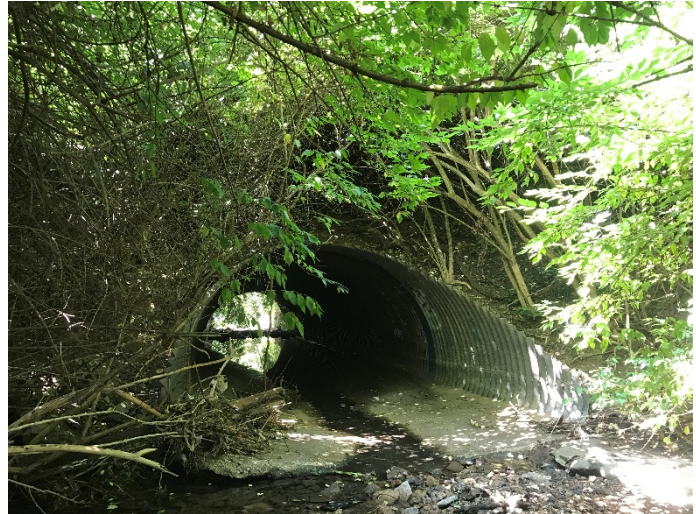
Bridge 95 - Grant's Trail Large CMP

General Info and Condition	
Install Date	Unknown
Greenway	Gravois
Maintained By	Great Rivers Greenway
General Condition	Fair
Vegetation Condition	Moderate

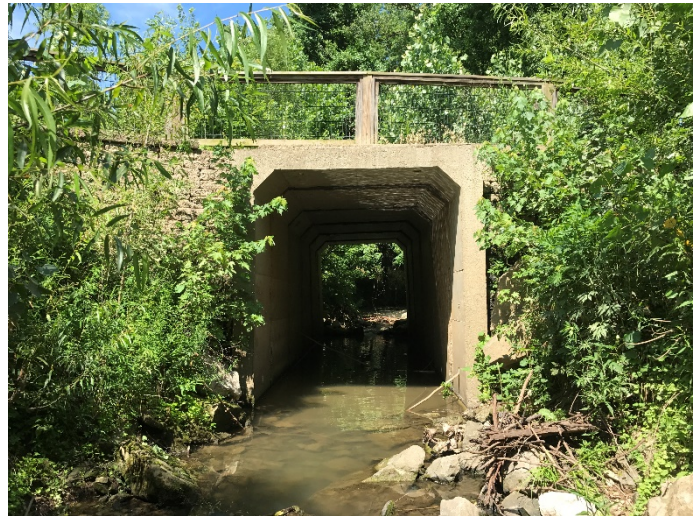
Bridge 99 - Rabbit Run Culvert A-2

General Info and Condition	
Install Date	2008
Greenway	Dardenne
Maintained By	St. Peters
General Condition	Good
Vegetation Condition	Moderate

Precast box culvert sections in good condition. Railing above culvert in fair condition. Not fully legible but something like "CMCC 7-31-08C 789?1259?" is carved in the faces at both openings of the culvert.

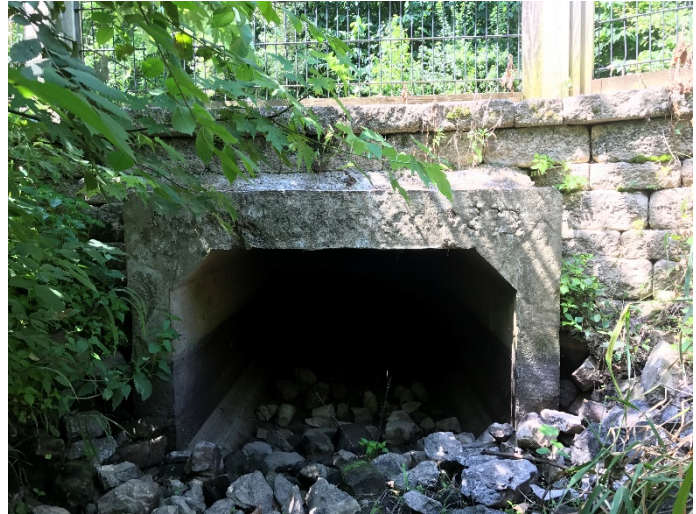
Bridge 100 - Rabbit Run Culvert A-3

General Info and Condition	
Install Date	2008
Greenway	Dardenne
Maintained By	St. Peters
General Condition	Good
Vegetation Condition	Moderate

Not fully legible, but something like "CMCC 8-13-08 C850 MO73?" is carved at the top outside face of each opening. Significant brush buildup at one opening. Vegetation grows all around.

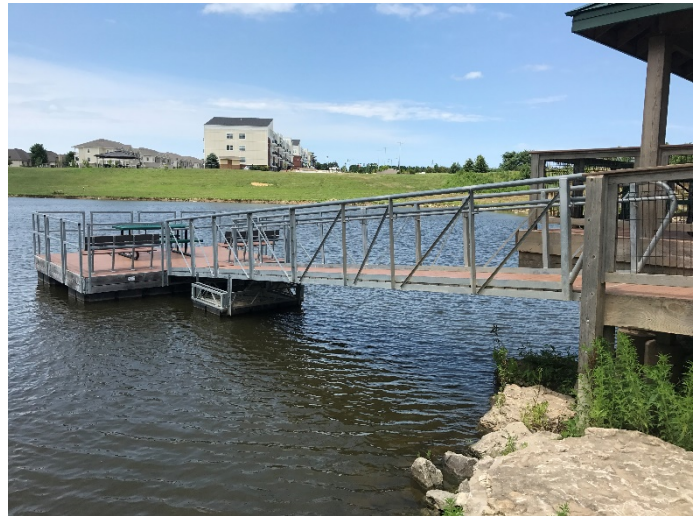
Bridge 101 - Vantage Park Dock Bridge

General Info and Condition	
Install Date	2013
Greenway	Dardenne
Maintained By	Cottleville
General Condition	Good
Vegetation Condition	None

Bridge is galvanized steel floating half-through Pratt truss by Tiger Docks® to a floating dock in the lake. Intermediate support is steel frame bridge floater. Bridge raises and lowers with changes in water surface elevation. East end of bridge is supported by elevated wooden pavilion structure.

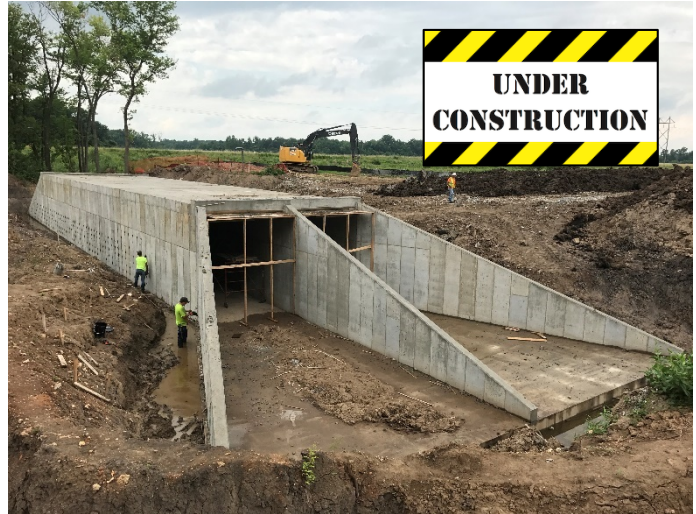
Bridge 102 - Hwy N Double Box Culvert

General Info and Condition	
Install Date	2017
Greenway	Dardenne
Maintained By	Cottleville
General Condition	Good
Vegetation Condition

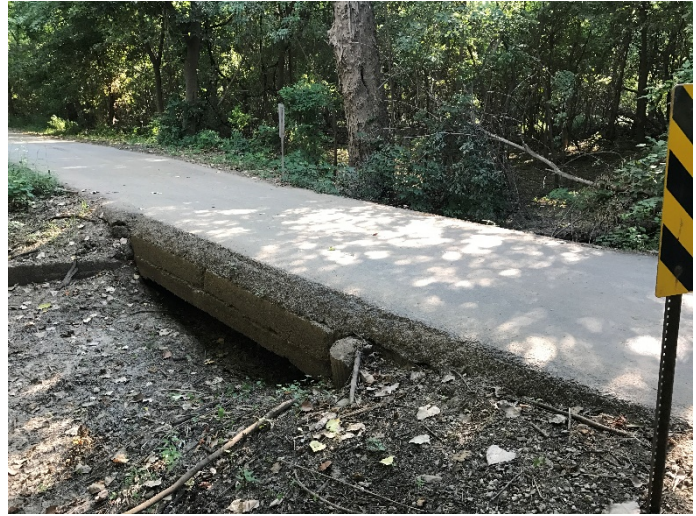
Bridge 135 - Lower Meramec Park Short Span Slab Bridge

General Info and Condition	
Install Date	Unknown
Greenway	Meramec
Maintained By	St. Louis County Parks
General Condition	Fair
Vegetation Condition	Light
